March 31, 2026

Re: Pre-Demolition Asbestos Inspection – Village of Oak Harbor Water Treatment Plant – Headworks & Trickle Pump Buildings

At your request, on Wednesday, March 25, 2026 HazCorp Environmental Services, Inc. performed a pre-demolition asbestos inspection on the Headworks and Trickle Pump Buildings at the Village of Oak Harbor Wastewater Treatment Plant located at 355 E. Water Street, Oak Harbor, Ohio 43449.

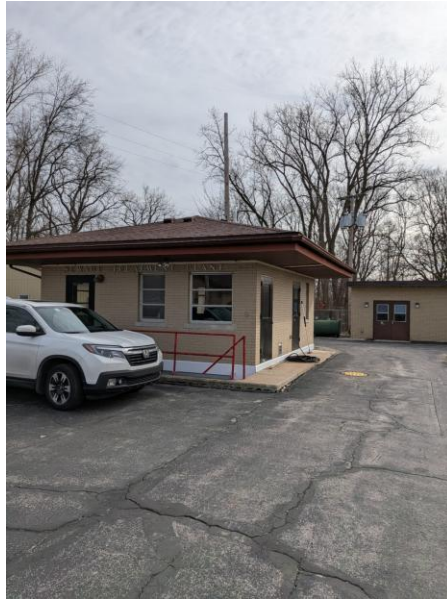
Material	Quantity	RACM (Friable)	Category I Non-Friable	Category II Non-Friable	Removal Required Prior to Renovation or Demolition?
Window glaze – doors and windows	7 windows and two exterior doors			X	This material will become friable during the renovation process and must be removed prior to demolition of the building. Removal is considered Class II asbestos abatement under OSHA.
Transite Asbestos Piping (PACM)	~ 45 linear feet of 2-foot diameter pipe			X	Removal is considered Class II asbestos abatement under OSHA. Transite materials will become friable if they are handled improperly. The Transite piping must be removed prior to demolition of the building.
Vibration Cloth (located in the first basement) (PACM)	Less than 2 square feet of vibration cloth installed adjacent to Transite pipe			X	This material is in good condition. However, it should be removed when the Transite pipe adjacent to it is removed and disposed. Removal is considered Class II work under OSHA.

Headworks Building – glaze on windows and doors contains asbestos.

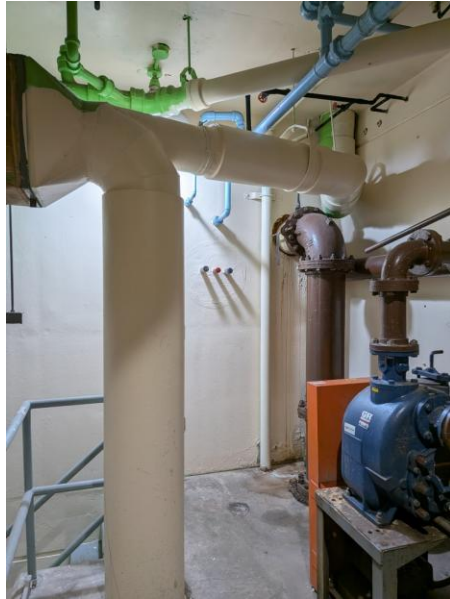
There are Asbestos Containing Transite pipes that are used to exhaust air on the two lower levels. It appears these pipes transition to metal once they are on the ground level floor of the building. There is vibration cloth connected to the Transite piping on the upper basement, this material was not tested as the exhaust was still in use on the day of the inspection; it is presumed to contain asbestos.

Transite piping on 1st basement level.

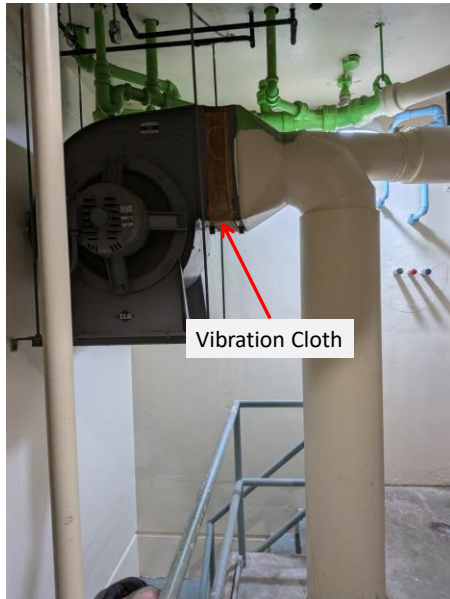
Transite pipe with PACM vibration cloth.

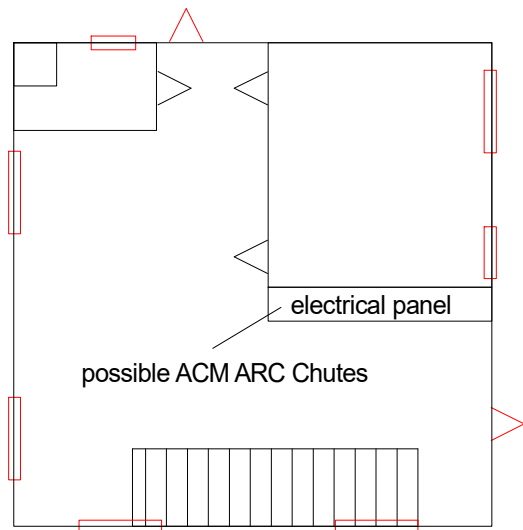
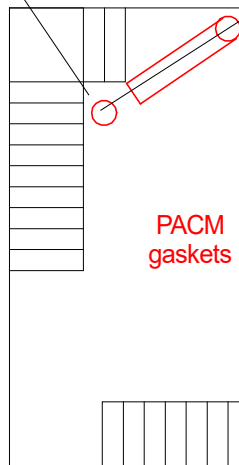
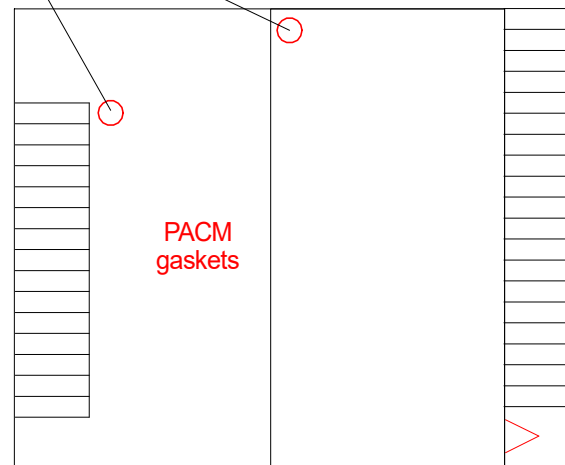
**Headworks Bldg.
355 E. Water Street
Oak Harbor, OH 43449**

Windows and exterior doors
with ACM glaze/caulk

PACM Vibration Cloth

ACM Transite Pipes (2' dia. x 45')
