Addendum No. 1

This Addendum No. 1 modifies the original Request for Proposals for the Removal of Unsafe Structure(s) in City of Richmond dated May 2016.

Form Name: **IHCDA | BLN Pre-Bid Survey Results**
Submission Date: May 27, 2016 7:17:43 AM EDT

Date of Survey May 26, 2016
Name of Surveyor Greg Ubehlor
Applicant Name City of Richmond
Property Address 22 North 20th Street Richmond IN
Image of Property

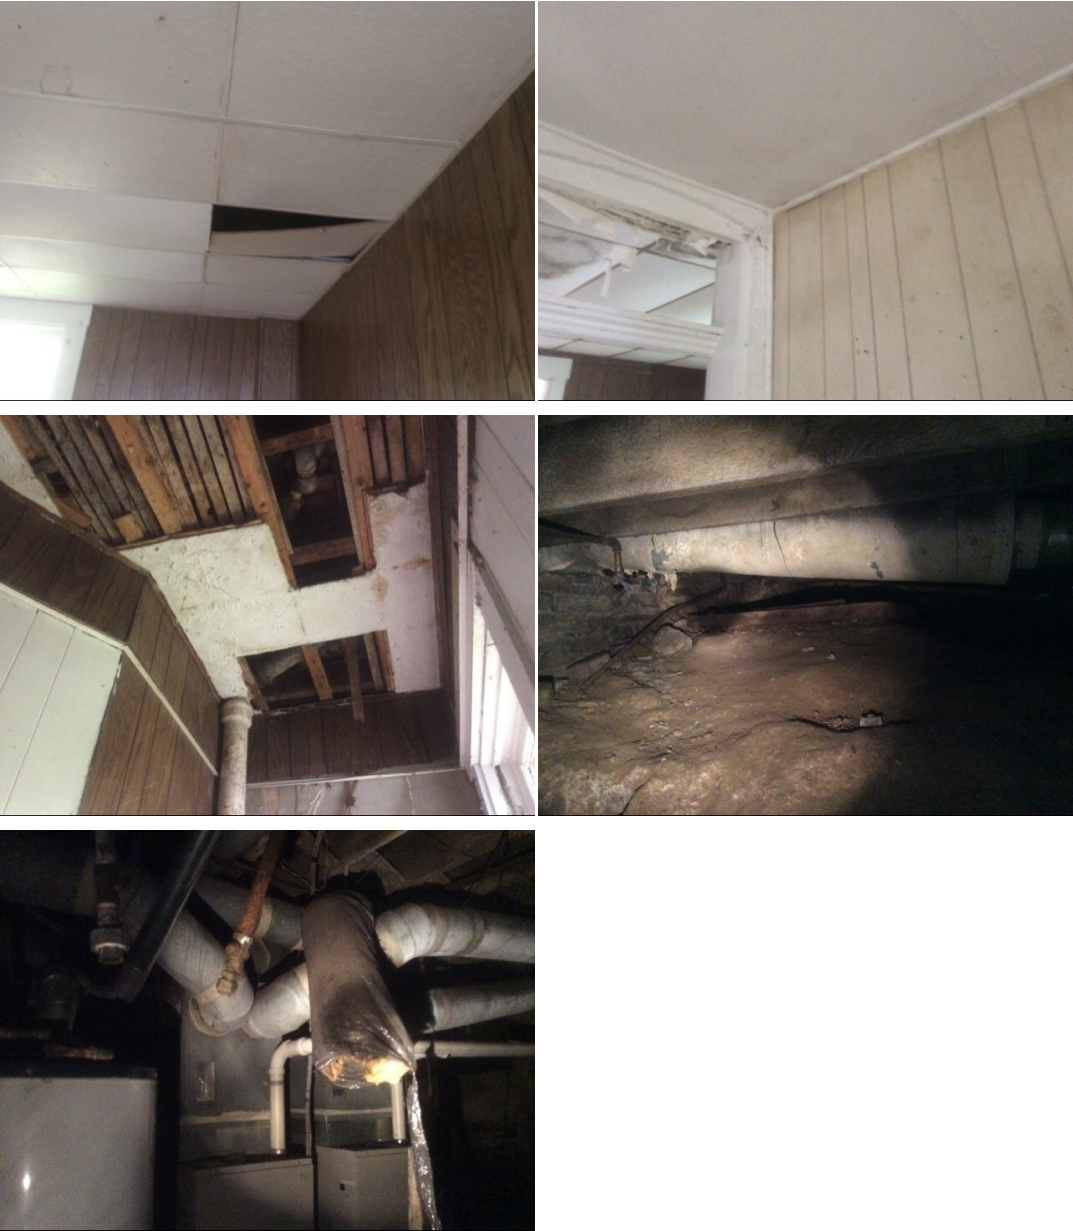
POTENTIAL ASBESTOS-CONTAINING MATERIALS (ACM) Yes
Room Multiple Rooms

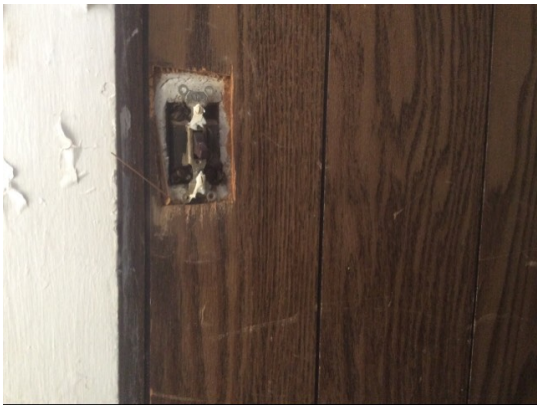
Mercury light switches

Yes

Multiple Rooms

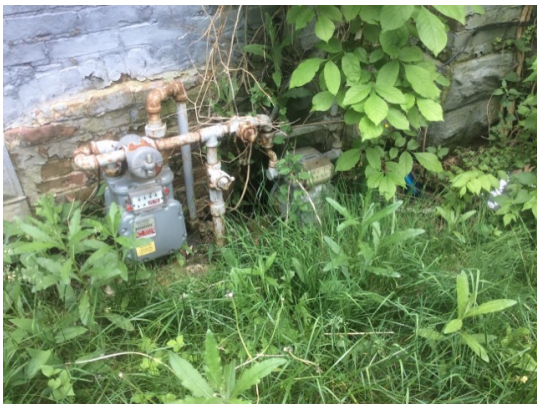
Mercury-containing gas pressure regulators

Yes

Exterior/Yard

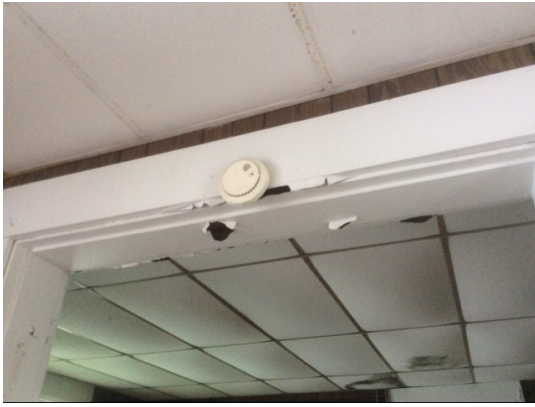
Smoke detectors

Yes

Multiple Rooms

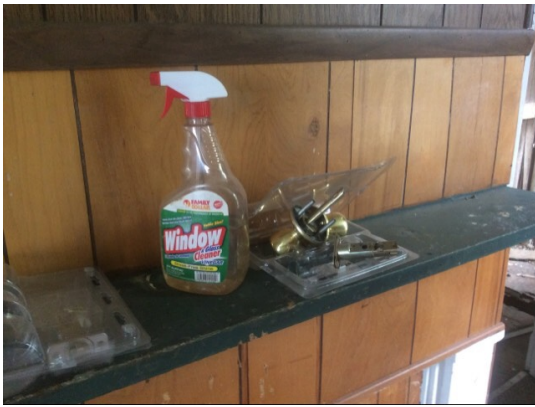
Chemicals

Yes

Living Room

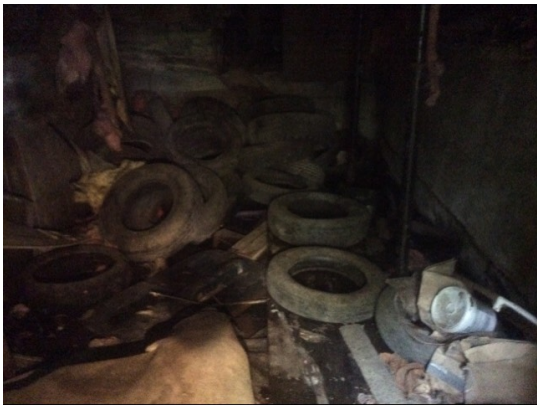
Scrap tires

Yes

Basement

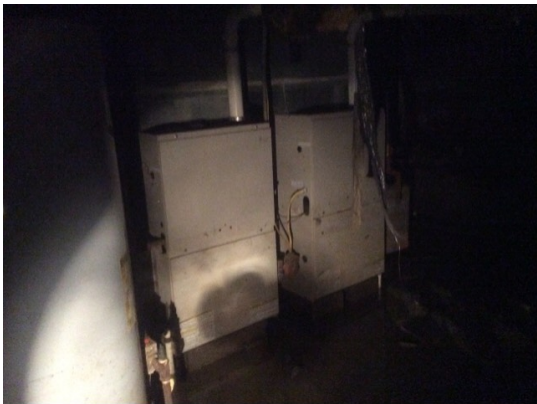
Major appliances

Yes

Basement

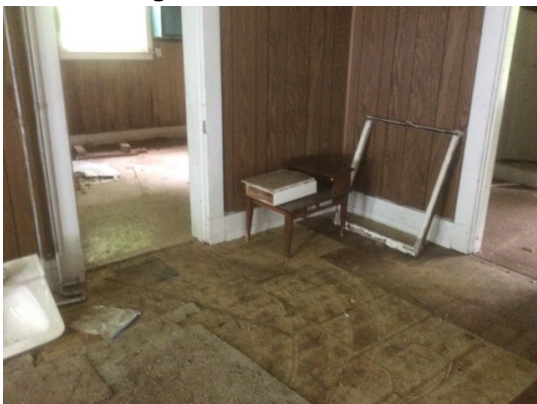
Furniture

Yes

Dining

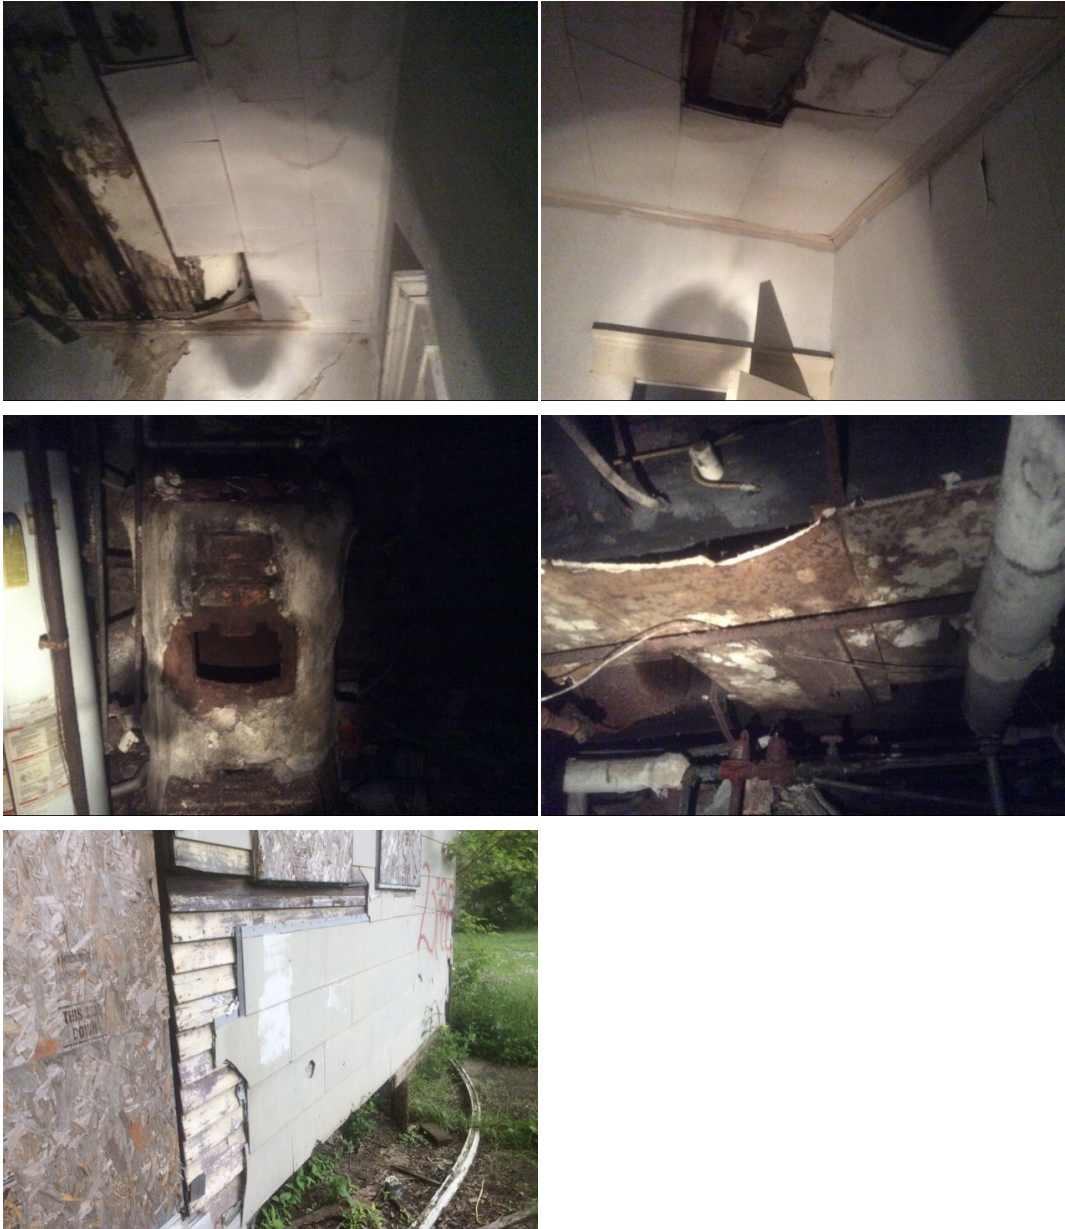
POTENTIAL ASBESTOS-CONTAINING MATERIALS (ACM) Yes
Room Multiple Rooms

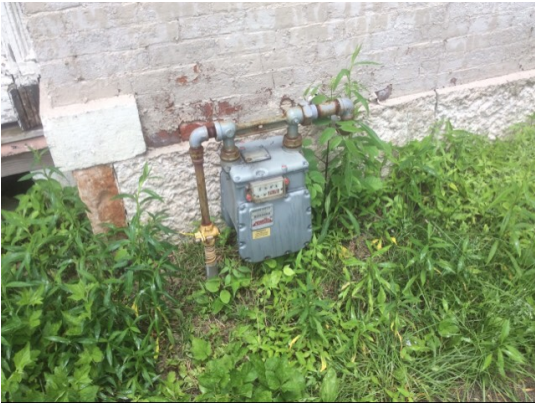
Mercury-containing gas pressure regulators
Room

Yes
Exterior/Yard

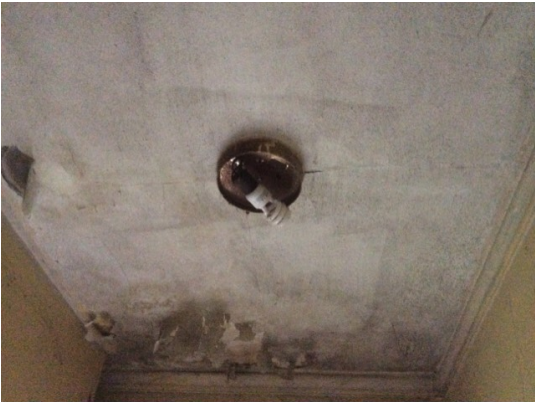
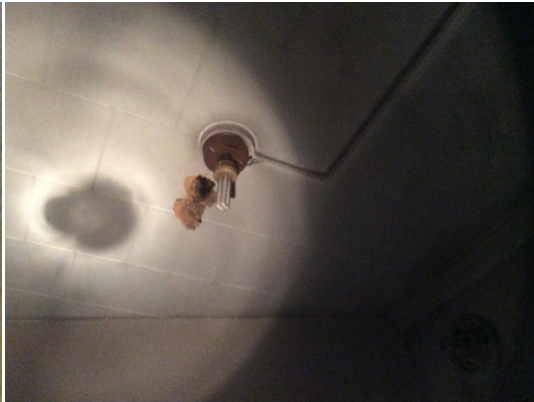
Fluorescent, high-intensity discharge (HID), and low pressure sodium lamp bulbs

Yes

Bathroom

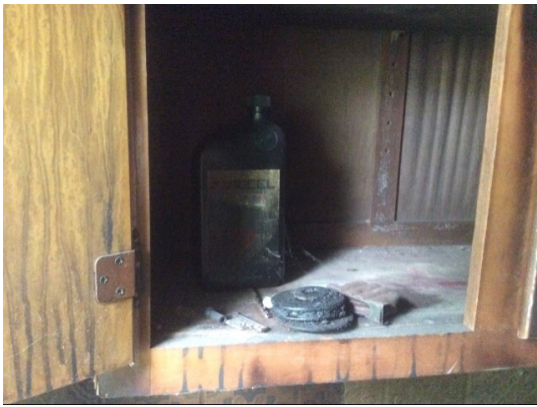
Used oil

Yes

Carriage House

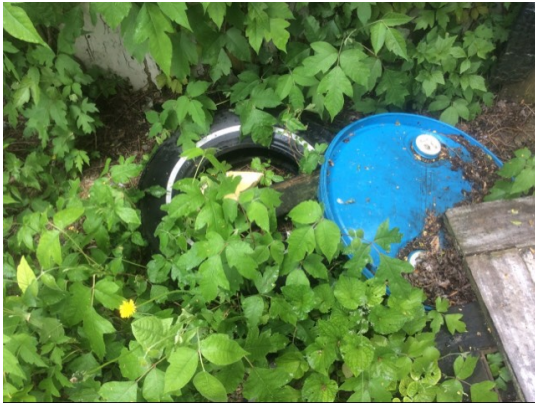
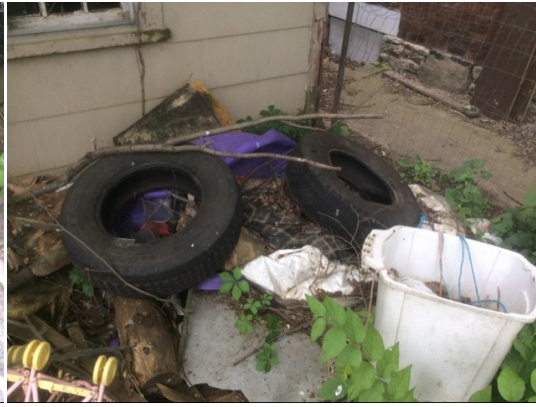
Scrap tires

Yes

Multiple Rooms

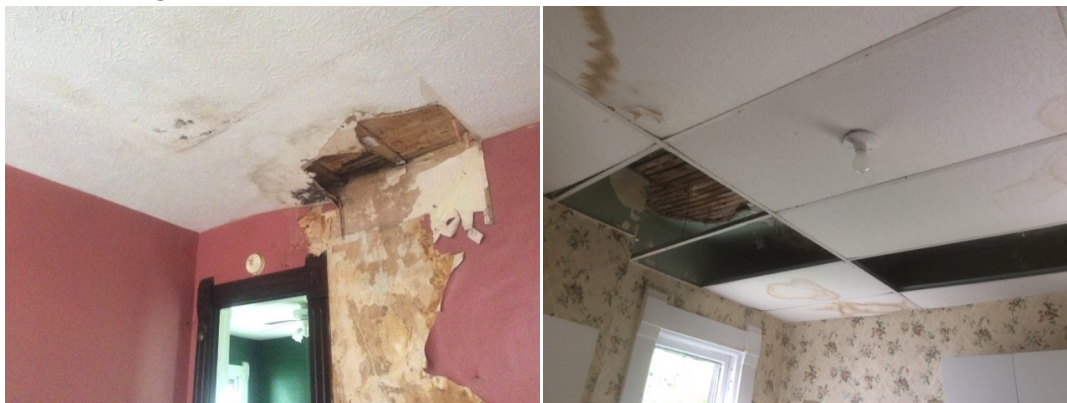
POTENTIAL ASBESTOS-CONTAINING MATERIALS (ACM) Yes
Room Multiple Rooms

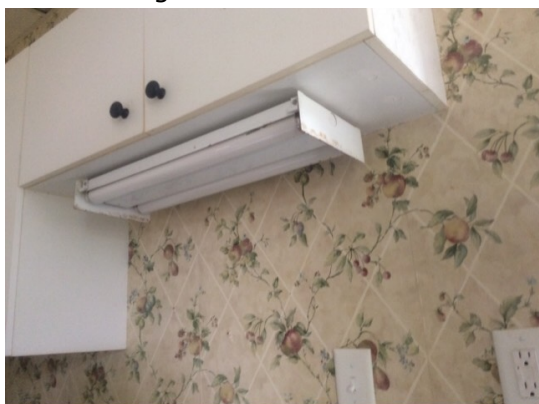
POLYCHLORINATED BIPHENYLS (PCBs)

Yes

Kitchen

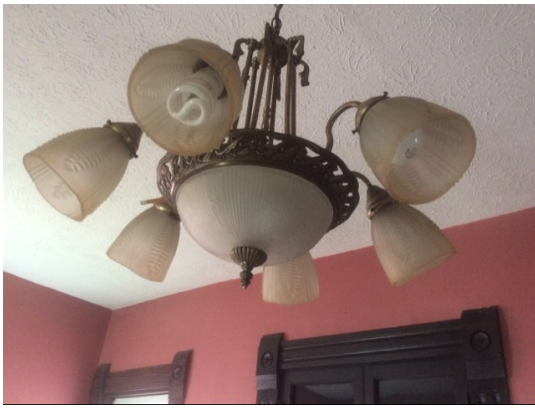
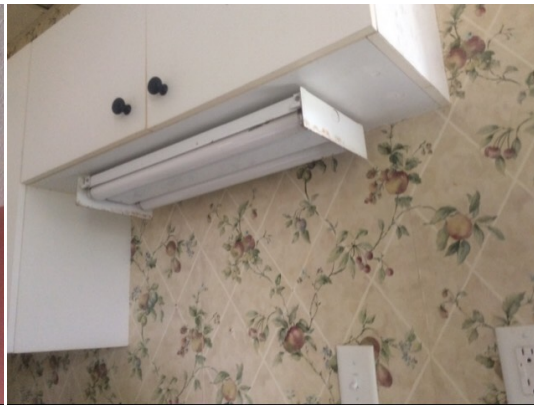
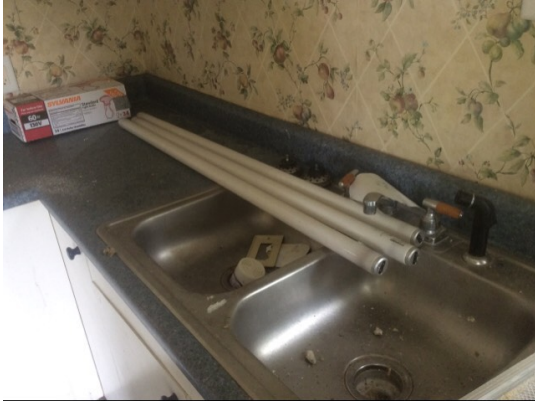
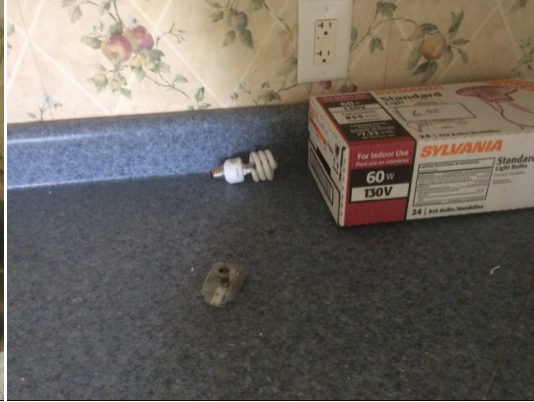
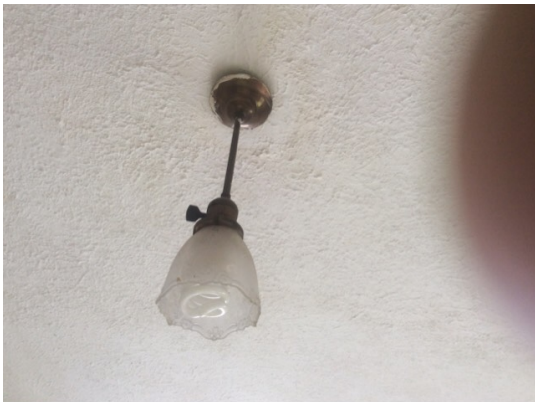
Batteries	No
Fluorescent, high-intensity discharge (HID), and low pressure sodium lamp bulbs	Yes
Room	Multiple Rooms
Attach Image

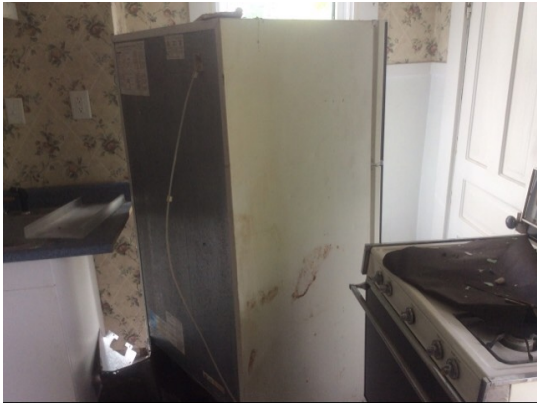
Refrigerant (found in air conditioners, refrigerators, freezers and dehumidifiers)

Yes

Kitchen

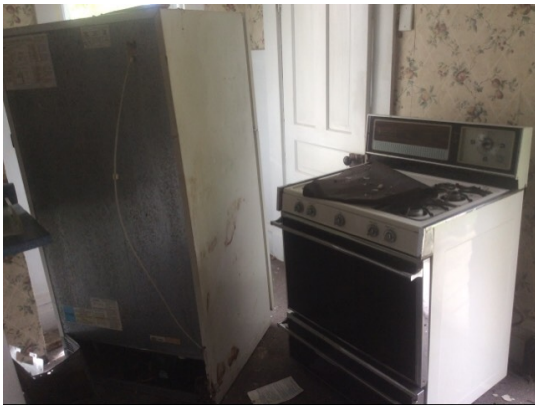
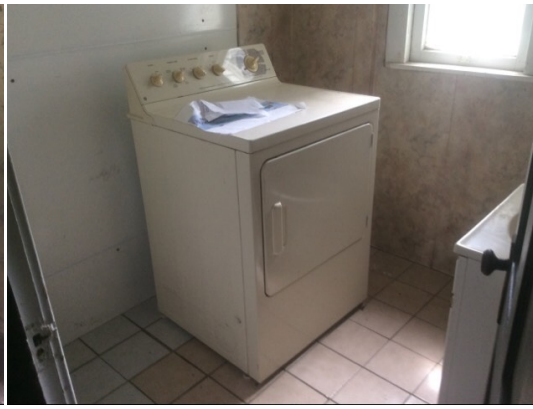
Medical waste (syringes)	No
Mechanical equipment (lawn mowers, etc.)	No
Scrap tires	No
Major appliances Room Attach Image	Yes Multiple Rooms

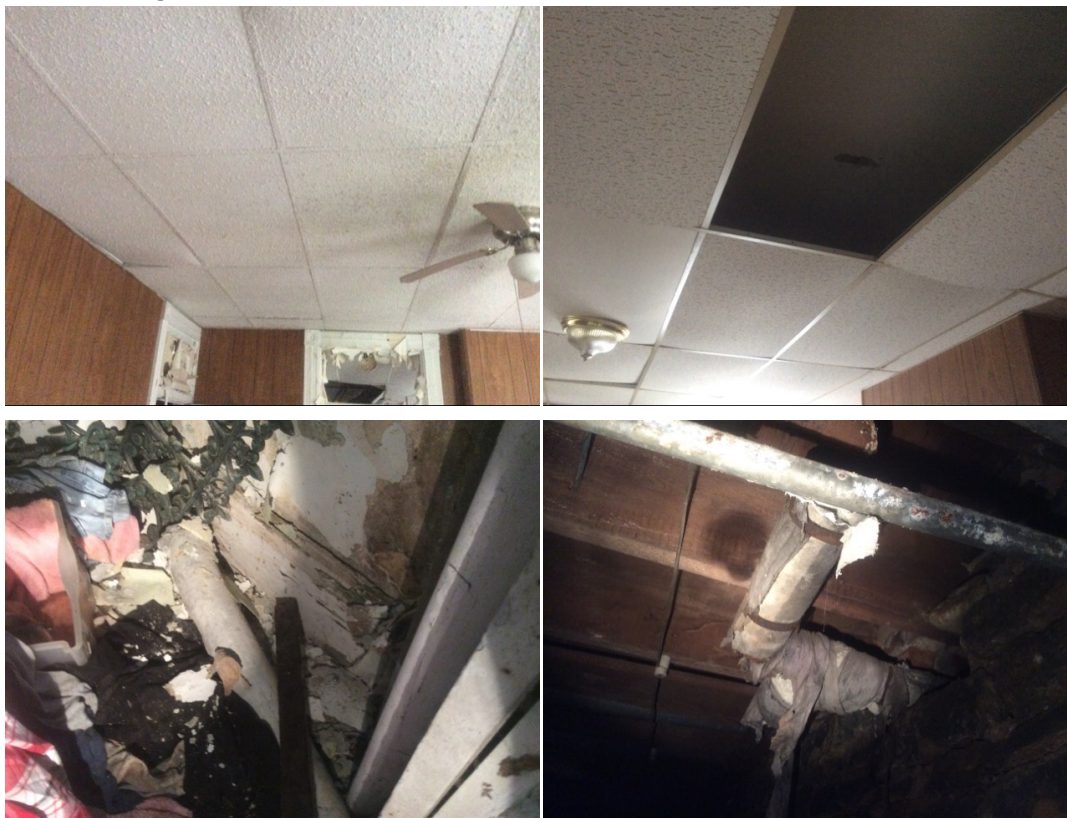
POTENTIAL ASBESTOS-CONTAINING MATERIALS (ACM) Yes
Room Multiple Rooms

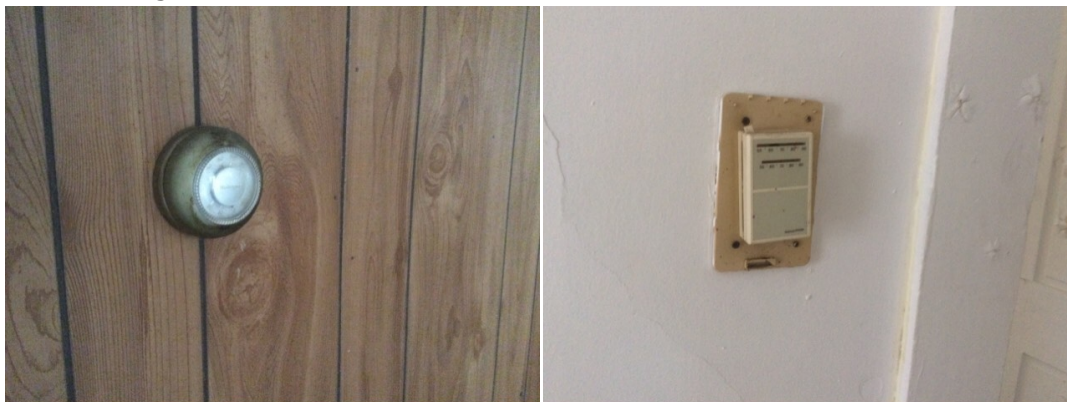
Mercury-containing thermostats

Yes

Multiple Rooms

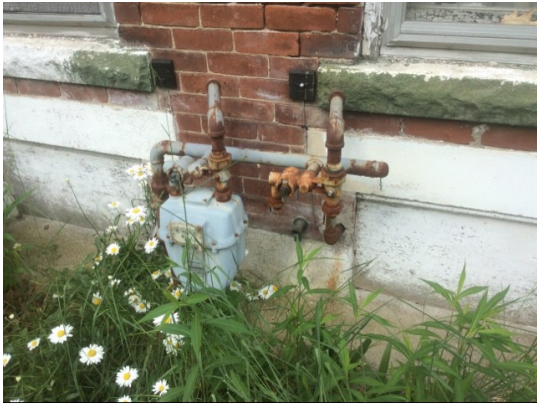
Mercury-containing gas pressure regulators

Yes

Exterior/Yard

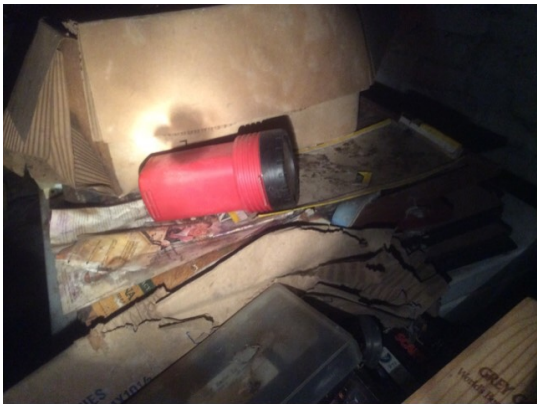
Batteries

Yes

Basement

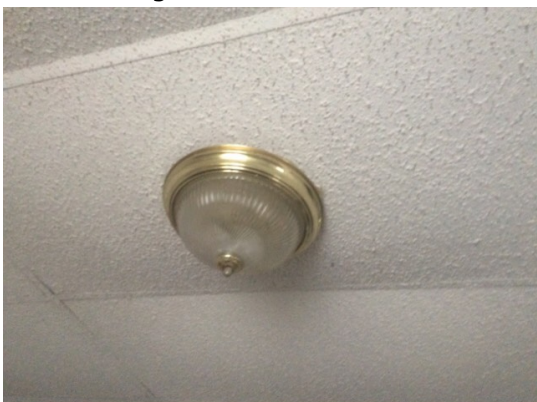
Fluorescent, high-intensity discharge (HID), and low pressure sodium lamp bulbs

Yes

Bedroom

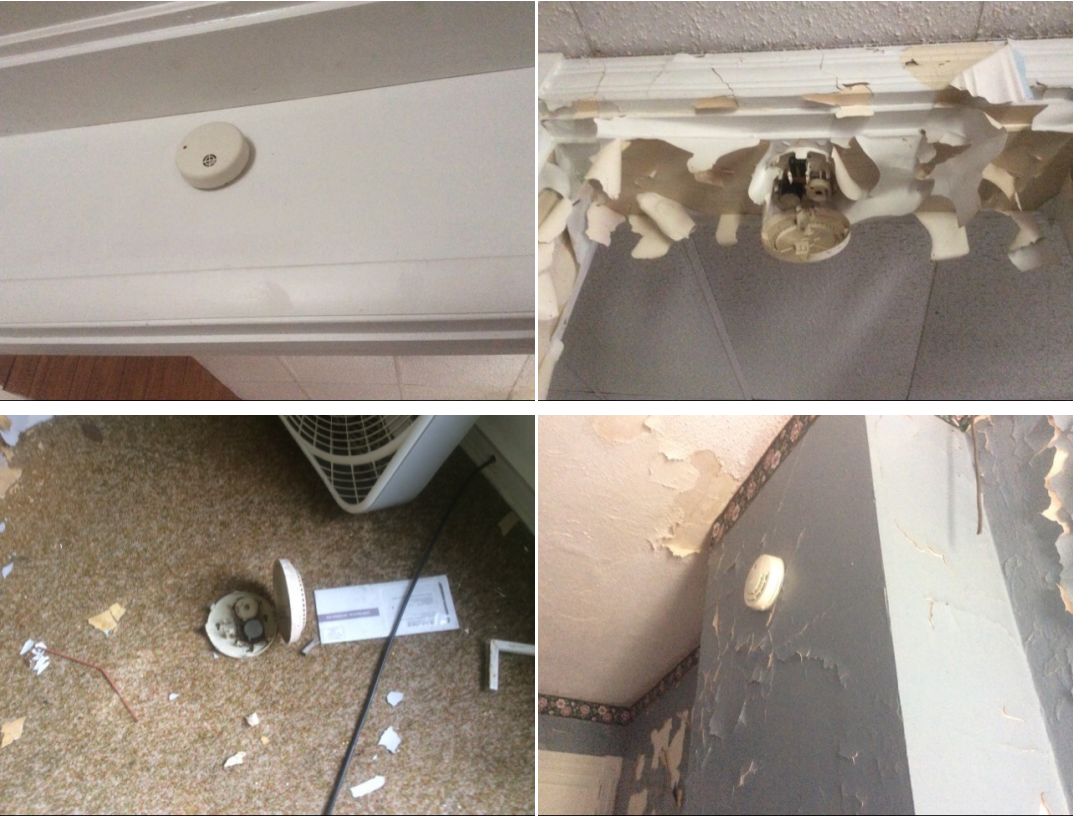
Smoke detectors

Yes

Multiple Rooms

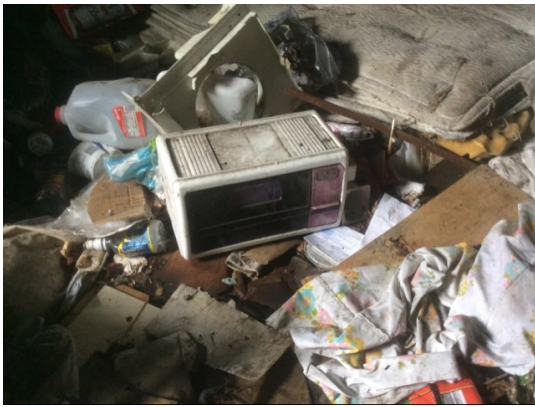
Fire extinguishers	No
Compressed gas cylinders	No
Electronics	Yes
Room	Multiple Rooms
Attach Image

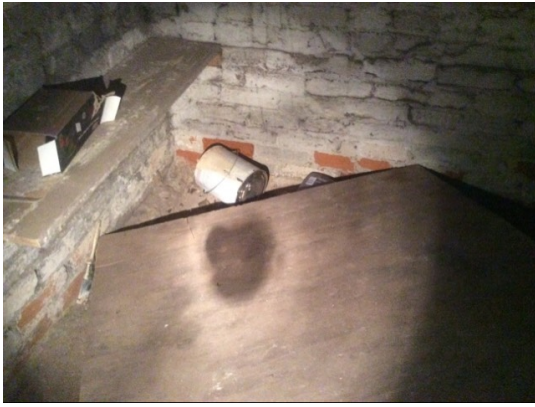
Paints
Room
Attach Image

Yes
Basement

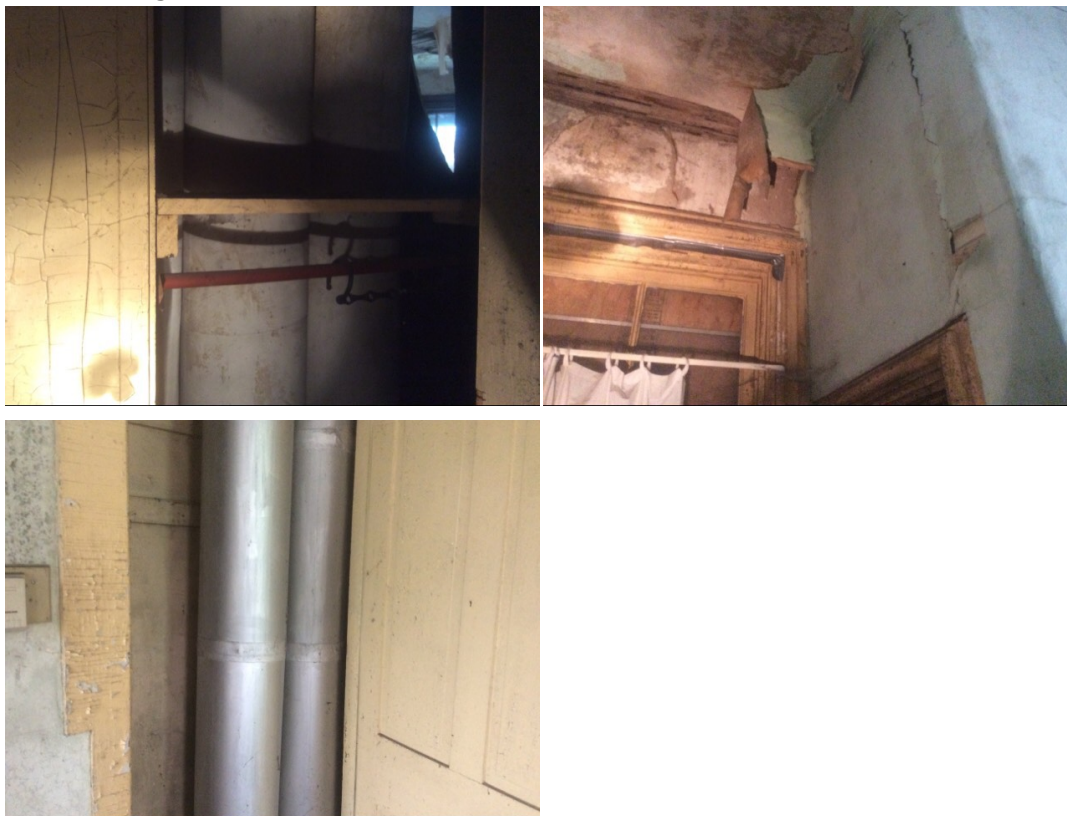
POTENTIAL ASBESTOS-CONTAINING MATERIALS (ACM) Yes
Room Multiple Rooms

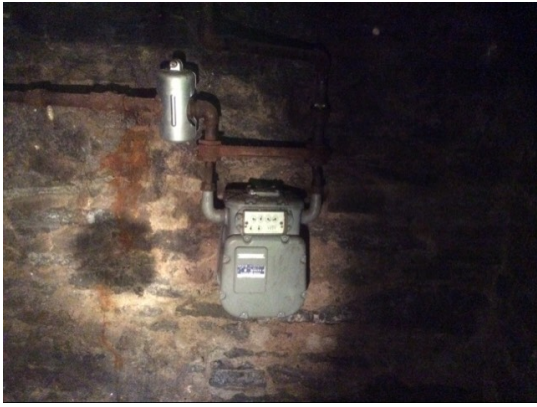
Mercury-containing gas pressure regulators

Yes

Basement

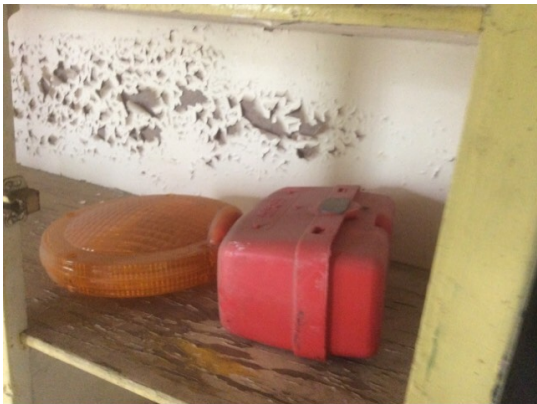
Batteries

Yes

Bedroom

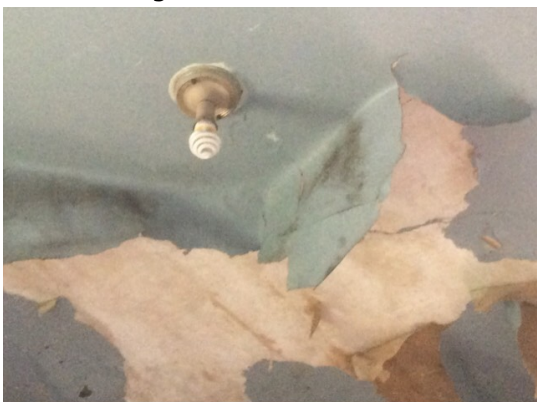
Fluorescent, high-intensity discharge (HID), and low pressure sodium lamp bulbs

Yes

Upper hall

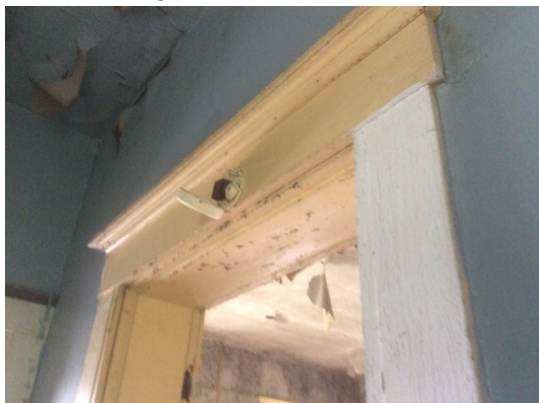
Smoke detectors

Yes

Multiple Rooms

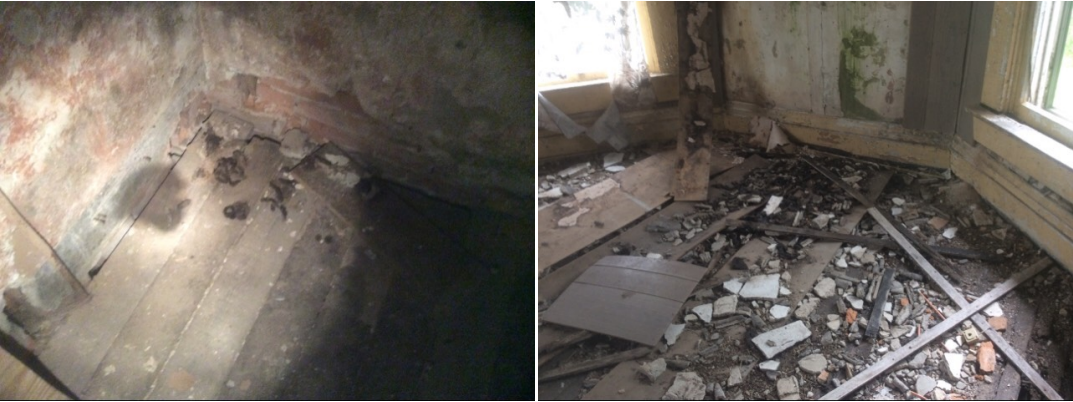
Pesticides	No
Paints	No
Solvents	No
Used oil	No
Fuels and fuel oil tanks	No
Biological waste (vermin, pigeon excrement) Room	Yes Multiple Rooms

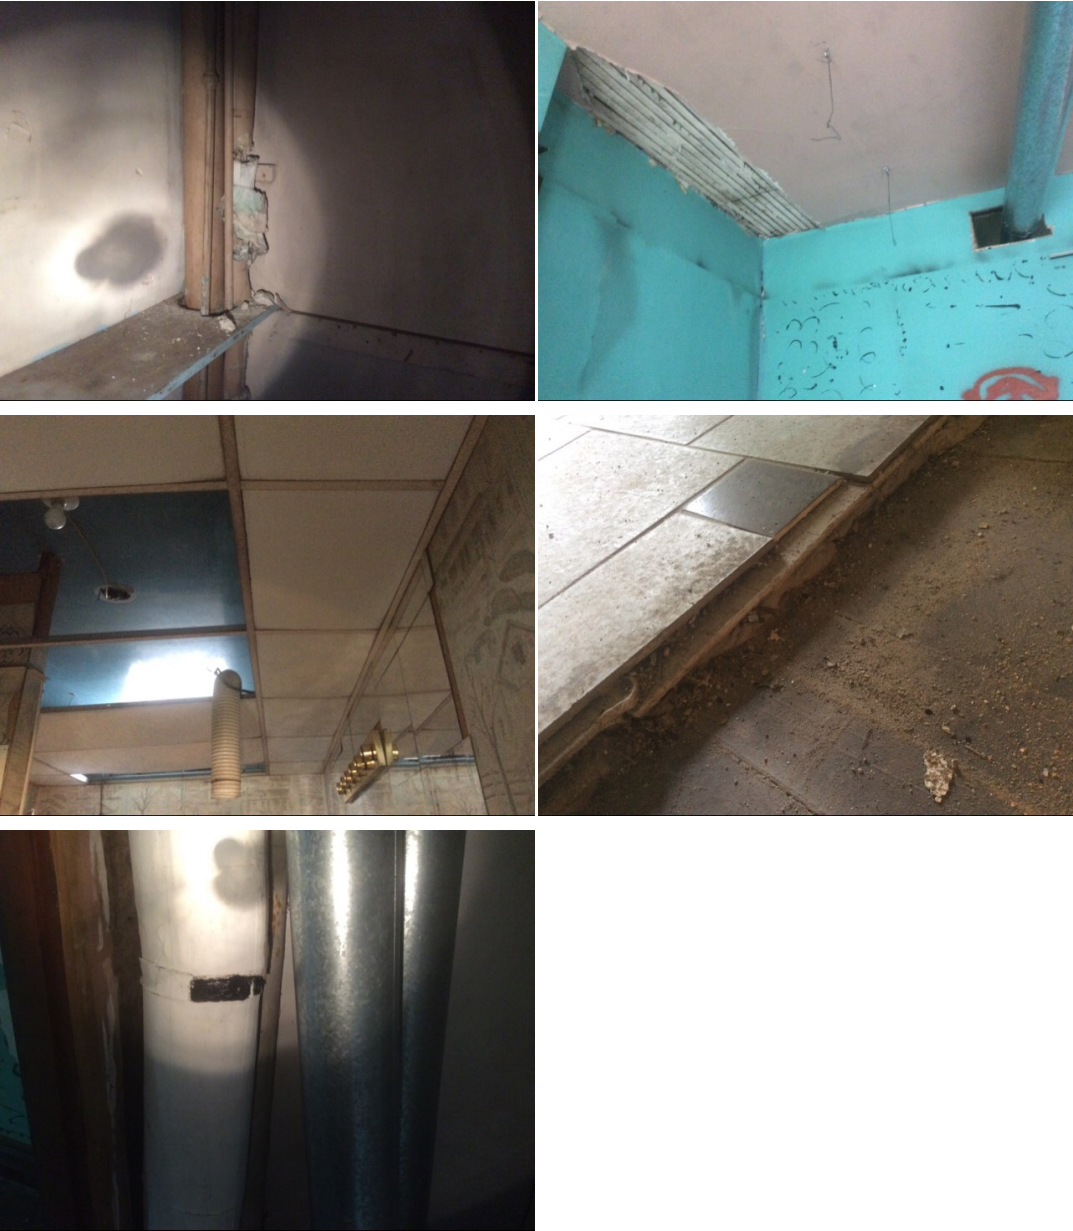
POTENTIAL ASBESTOS-CONTAINING MATERIALS (ACM) Yes
Room Multiple Rooms

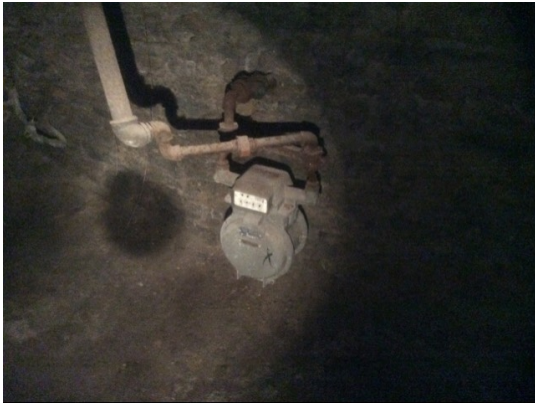
POLYCHLORINATED BIPHENYLS (PCBs)	No
Mercury light switches	No
Mercury-containing thermostats	No
Mercury-containing gas pressure regulators	Yes
Room	Basement
Attach Image

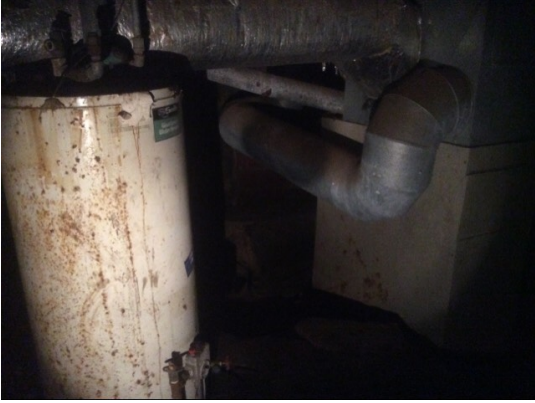
Scrap tires	No
Major appliances	Yes
Room	Basement
Attach Image

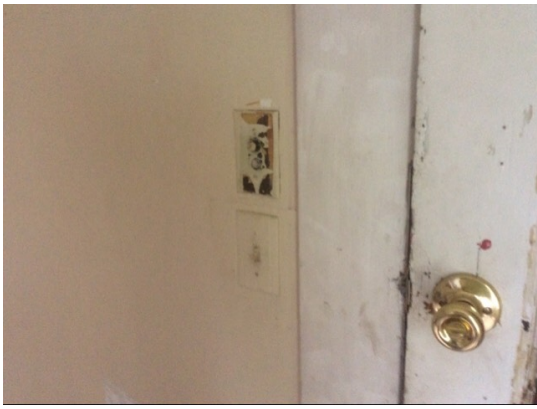
Mercury light switches

Yes

Living Room

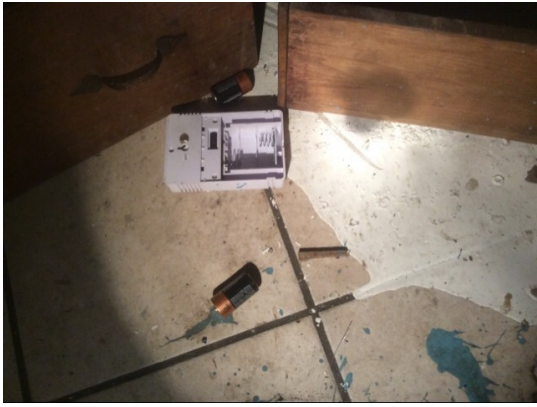
Batteries

Yes

Kitchen

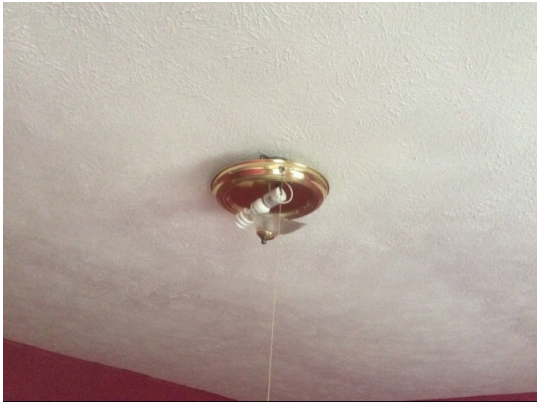
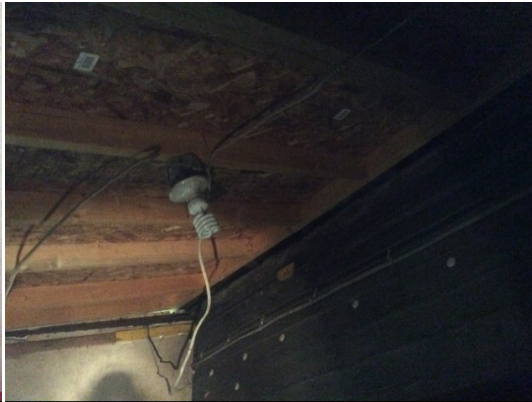
Fluorescent, high-intensity discharge (HID), and low pressure sodium lamp bulbs

Yes

Multiple Rooms

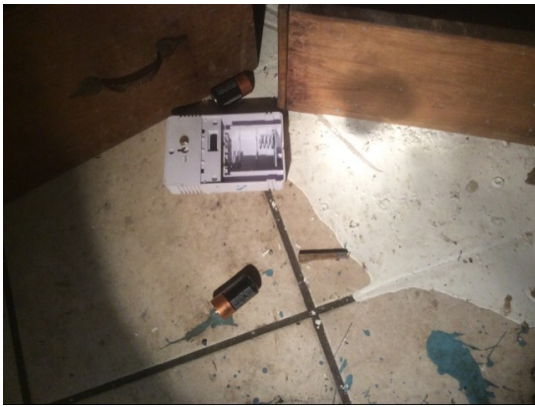
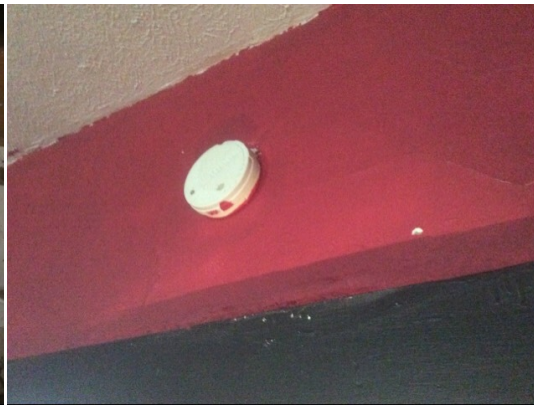
Smoke detectors

Yes

Multiple Rooms

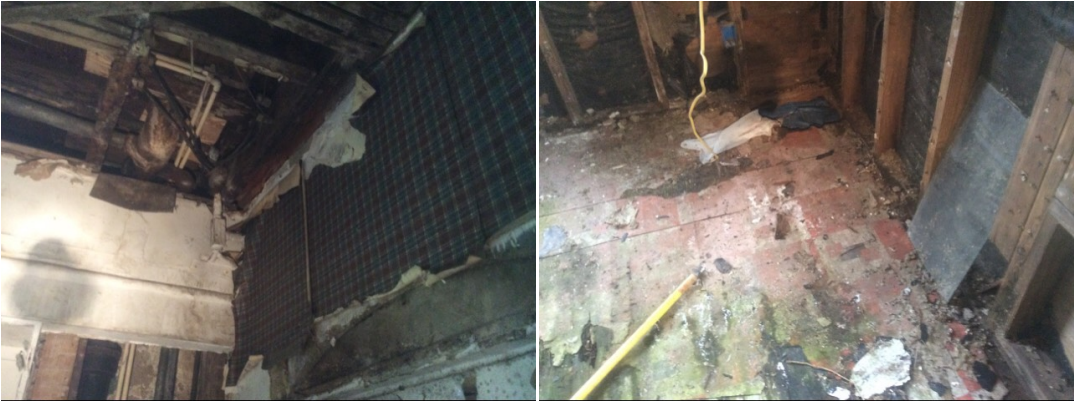
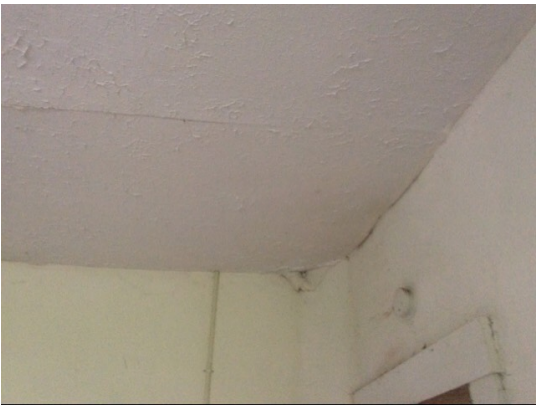
POTENTIAL ASBESTOS-CONTAINING MATERIALS (ACM) Yes
Room Multiple Rooms

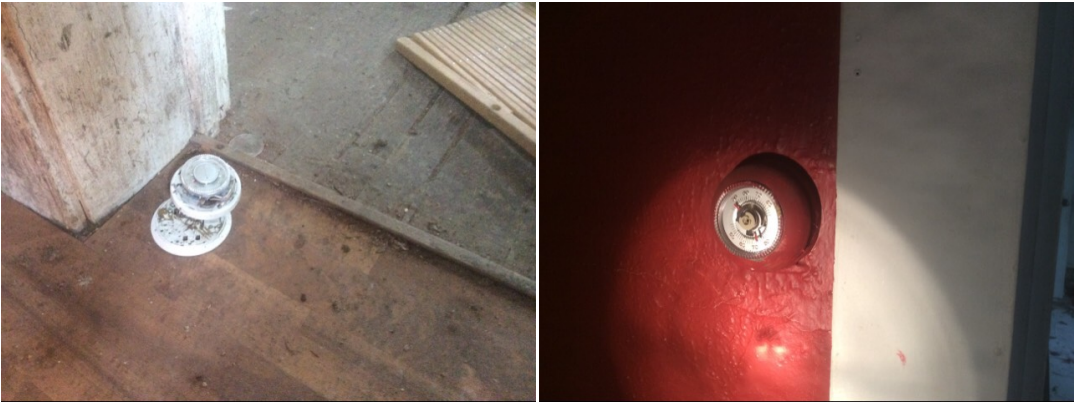
POLYCHLORINATED BIPHENYLS (PCBs)	No
Mercury light switches	No
Mercury-containing thermostats	Yes
Room	Multiple Rooms

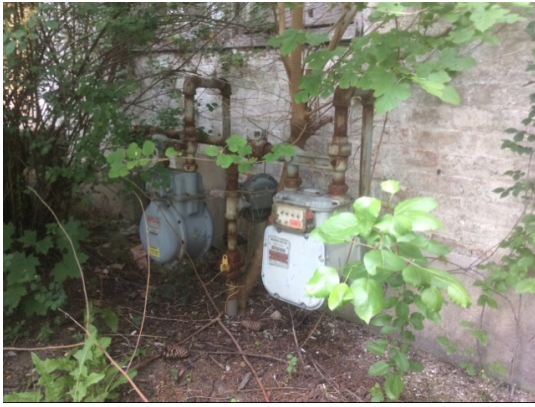
Mercury-containing gas pressure regulators	Yes
Room	Exterior/Yard
Attach Image

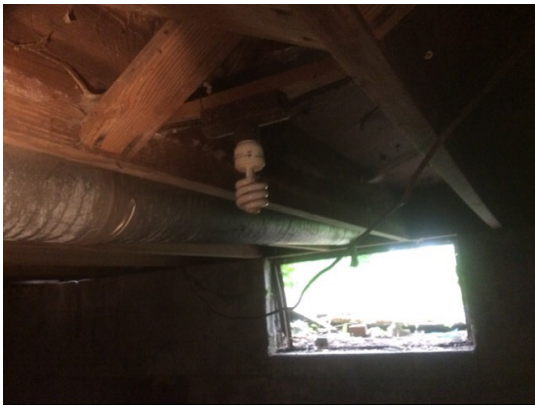
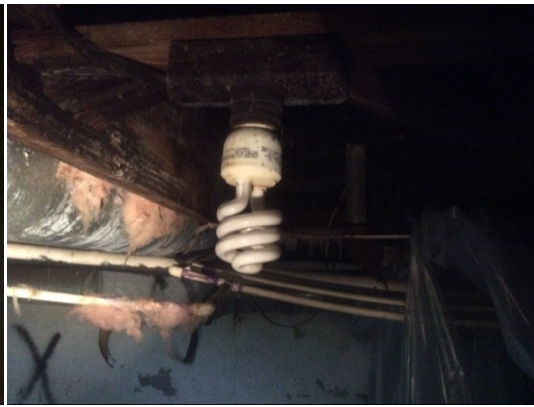
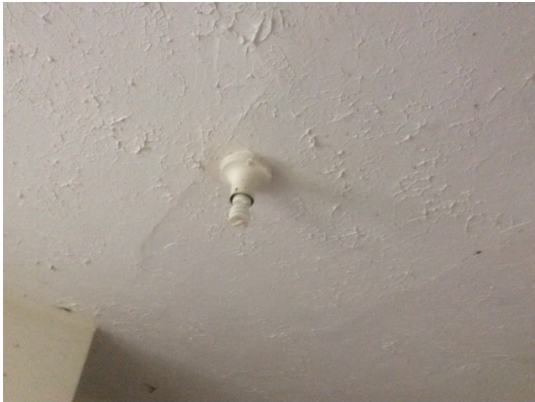
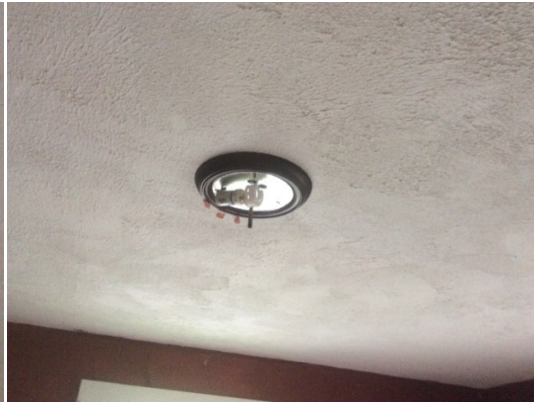
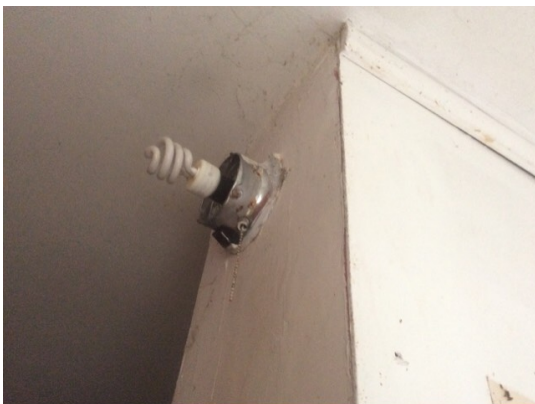
Yes

Basement

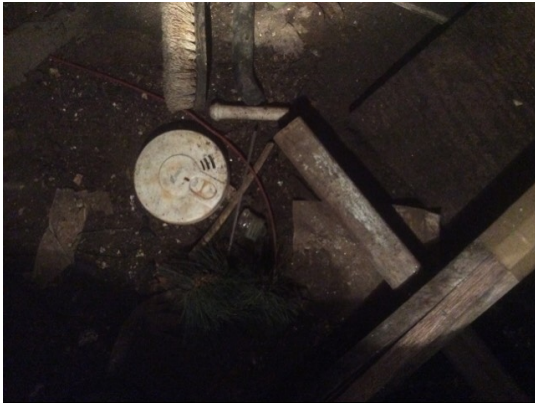
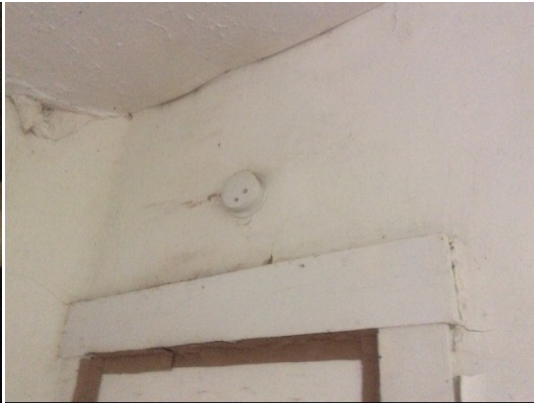
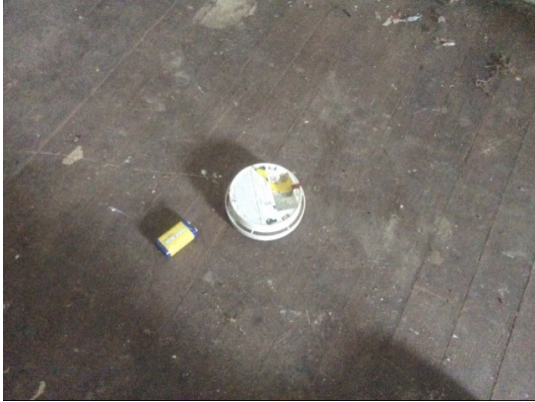
Smoke detectors	Yes
Room	Multiple Rooms
Attach Image

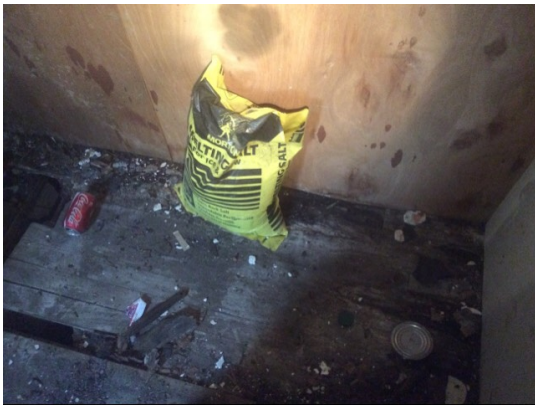
Fire extinguishers	No
Compressed gas cylinders	No
Electronics	No
Chemicals	Yes
Room	Multiple Rooms
Attach Image

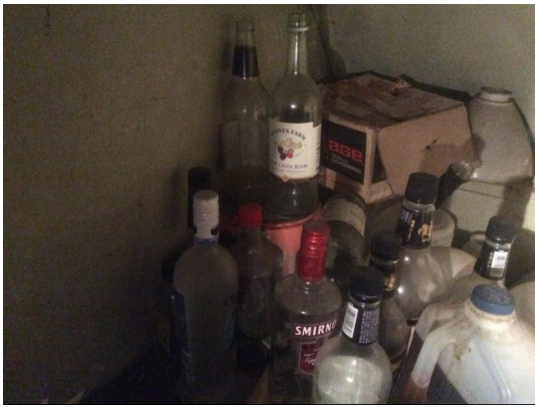
Yes

Multiple Rooms
