Addendum #4
Construction Manager as Constructor Services
Hangar 2003 Renovations
Fort Wayne International Airport

Issued: September 5, 2025

Ref: Asbestos Survey
Hangar 2003
4555 Altitude Drive
Fort Wayne, Allen County, Indiana 46809
SES Project No.: 2025-0766

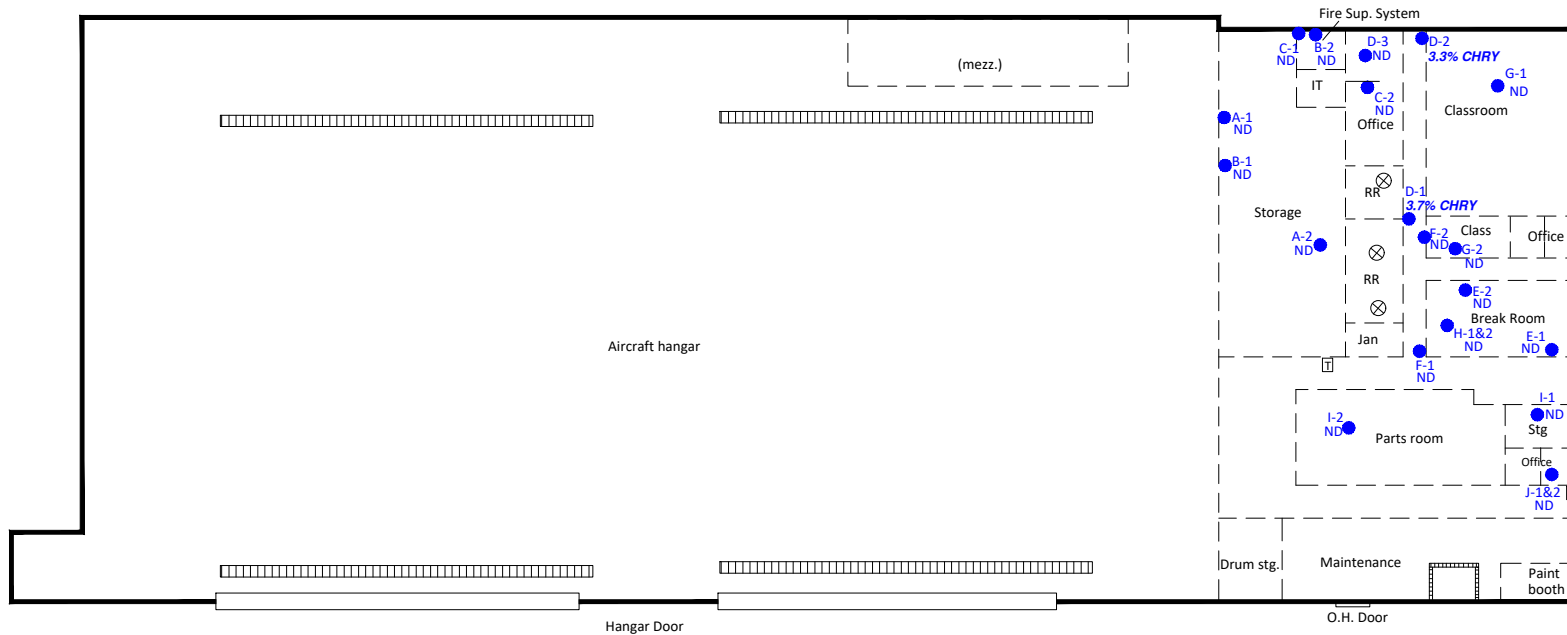
Asbestos laboratory testing results are summarized in Table 1. A site map indicating approximate sample locations is presented in Attachment A. Copies of the laboratory report and chain-of-custody documentation are presented as Attachment B.

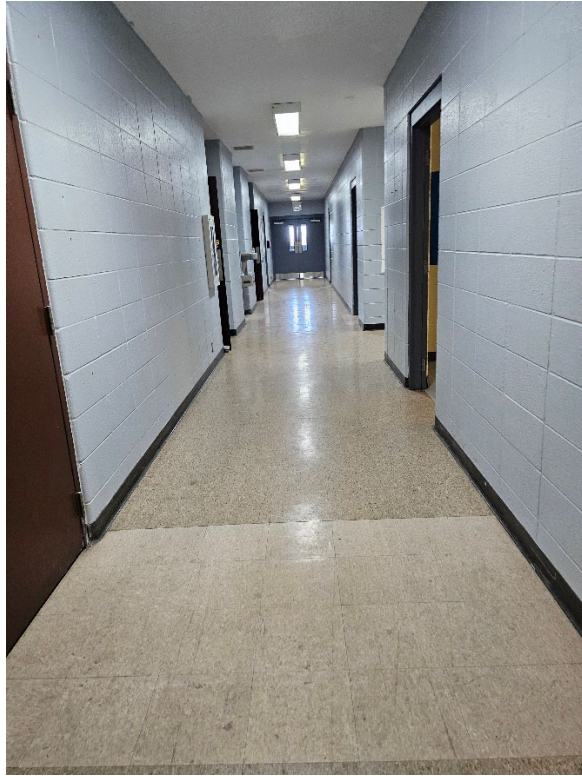
Photo 1: View of the office area hallway.

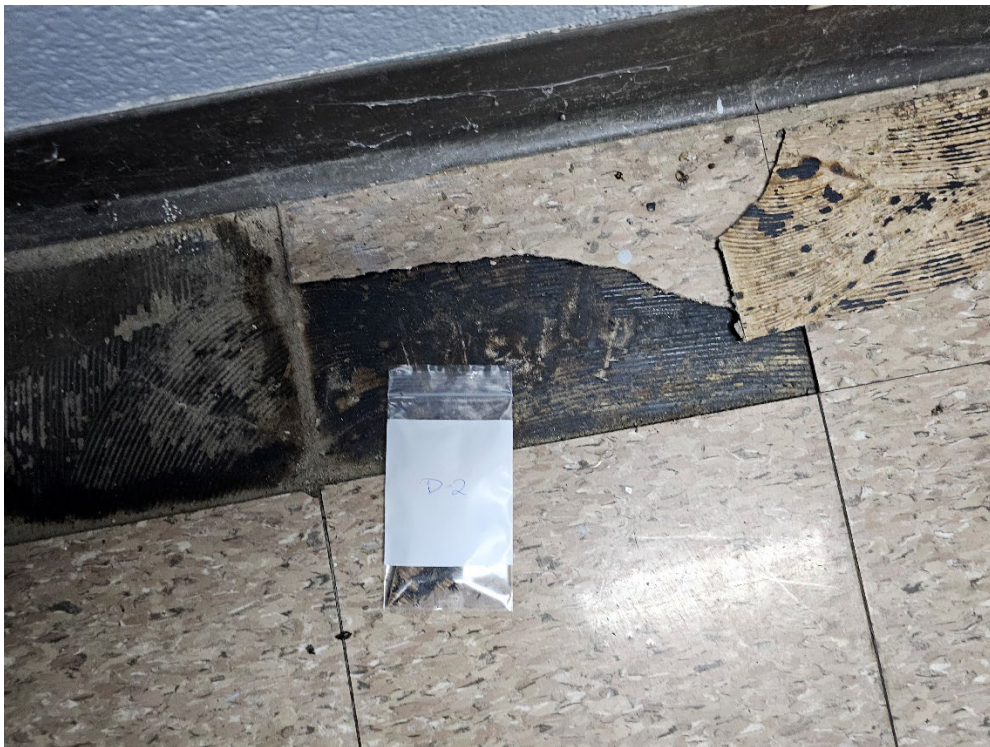
- Black mastic associated with light brown floor tiles observed in the office area hall and below carpet in the offices. Approximately 1,300 square feet of the material was observed.

This material is considered to be an ACBM according to EPA definition. As the material is a non-regulated ACM in good condition and the material will not be made friable during typical demolition activities, the material may be removed and sent to a permitted solid waste disposal site as solid waste.

Photo 2: View asbestos-containing black mastic below office hallway floor tile (Sample D-2)
