Addendum #4
Construction Manager as Constructor Services
Hangar 2003 Renovations
Fort Wayne International Airport

Issued: September 5, 2025

Ref: Asbestos Survey
Hangar 2003
4555 Altitude Drive
Fort Wayne, Allen County, Indiana 46809
SES Project No.: 2025-0766

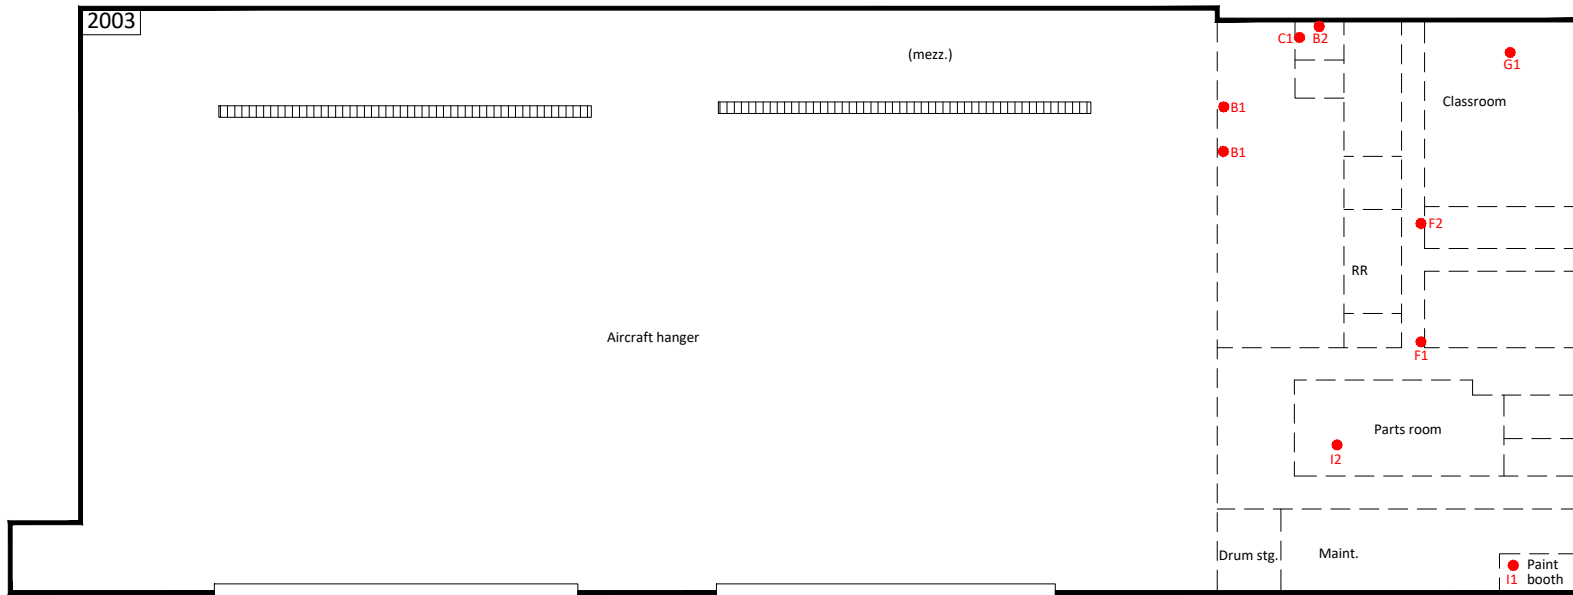
TITLE SAMPLE LOCATIONS - 2003 Hangers Asbestos Survey	LEGEND ● MATERIAL SAMPLE LOCATION ▬ FLOOR TRENCH	PROJECT 2025-0766		
		SCALE 1" = 50'	DATE 8/13/25	
LOCATION Commercial Properties Altitude Drive and West Perimeter Road Fort Wayne, Allen County, Indiana		DRAWN cb	CHECKED dn	
		FILE 20250766	FIGURE 2

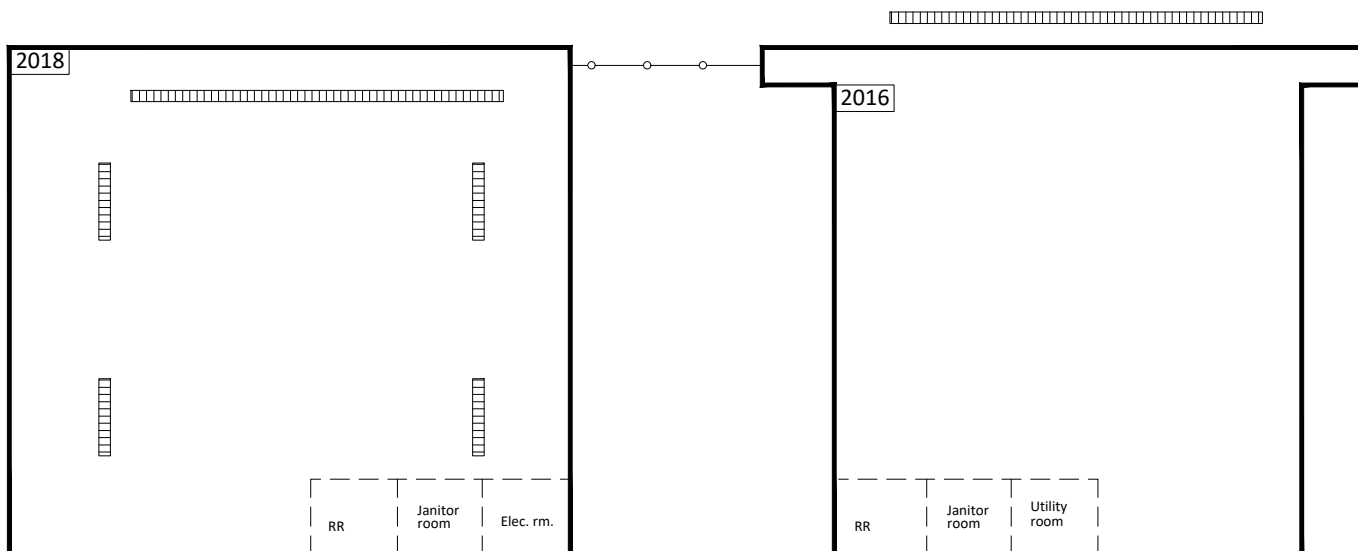
SAMPLE LOCATIONS - 2016 & 2018 Hangers Asbestos Survey		2025-0766		
LOCATION		SCALE	DATE	
		1" = 50'	8/13/25	
		DRAWN	CHECKED	
		cb	dn	
		FILE	FIGURE	
		20250766	3
