Addendum No. 1

This Addendum No. 1 modifies the original Request for Proposals for the Removal of Unsafe Structure(s) in City of Richmond dated May 2016.

Form Name: **IHCDA | BLN Pre-Bid Survey Results**
Submission Date: May 27, 2016 7:17:43 AM EDT

Date of Survey May 26, 2016
Name of Surveyor Greg Ubehlor
Applicant Name City of Richmond
Property Address 22 North 20th Street Richmond IN
Image of Property

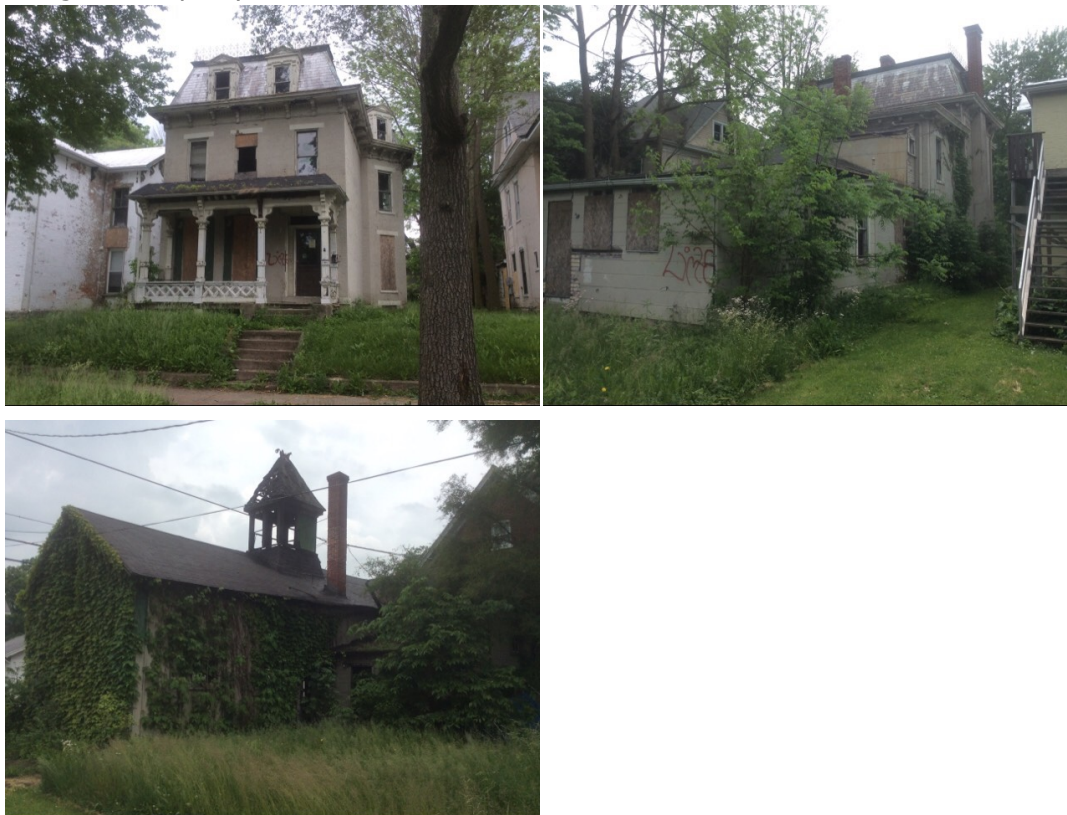
Date of Survey May 26, 2016
Name of Surveyor Greg Ubehlor
Applicant Name City of Richmond
Property Address 107 North 12th Street Richmond IN
Image of Property

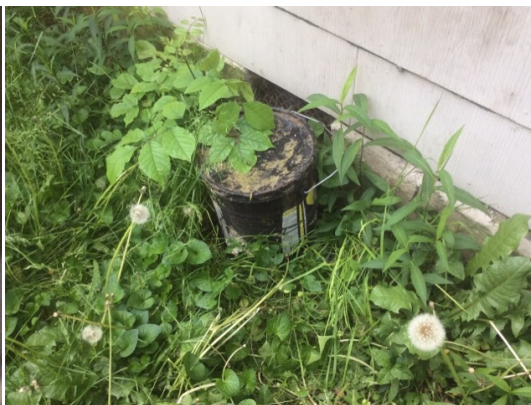
Kitchen

Chemicals

Yes

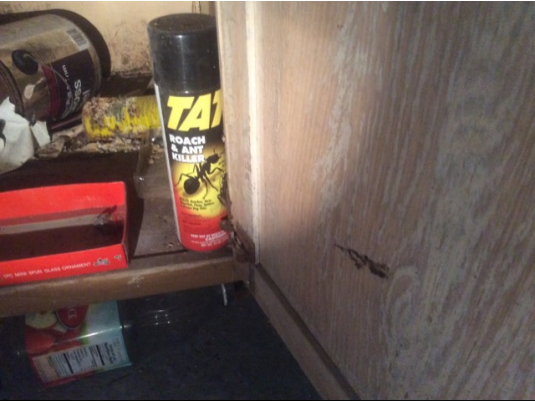
Kitchen

Pesticides

Yes

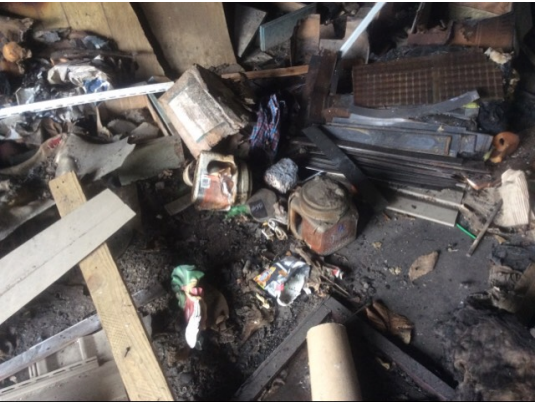
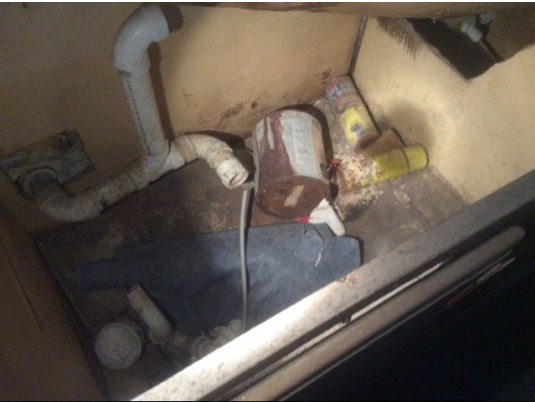
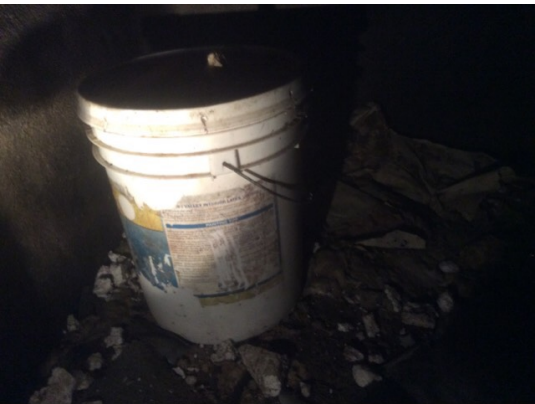
Multiple Rooms

Paints

Yes

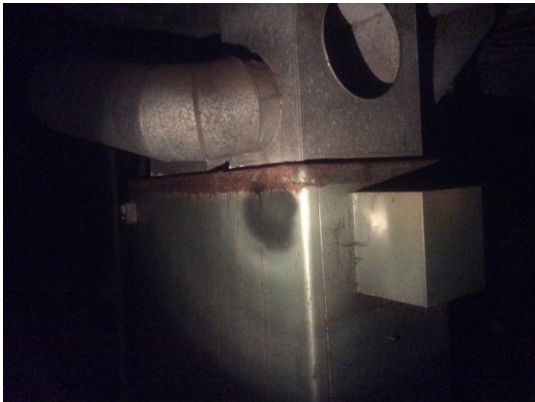
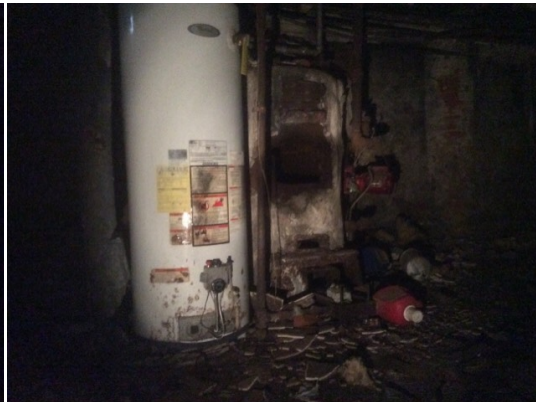
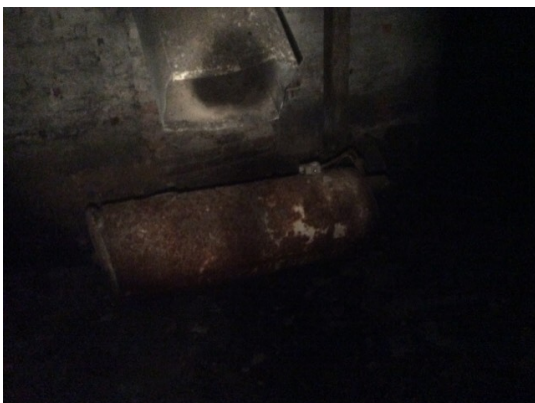
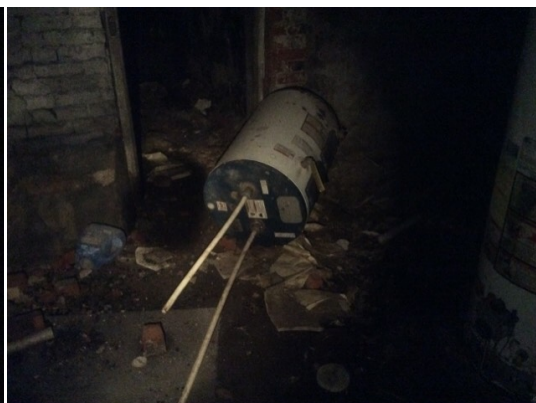
Major appliances
Room
Attach Image

Yes
Basement

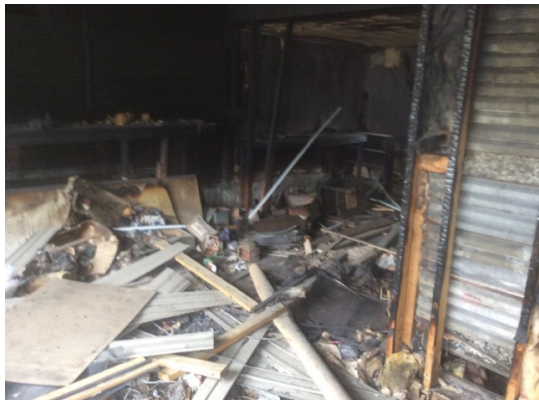
Multiple Rooms

Furniture

Yes

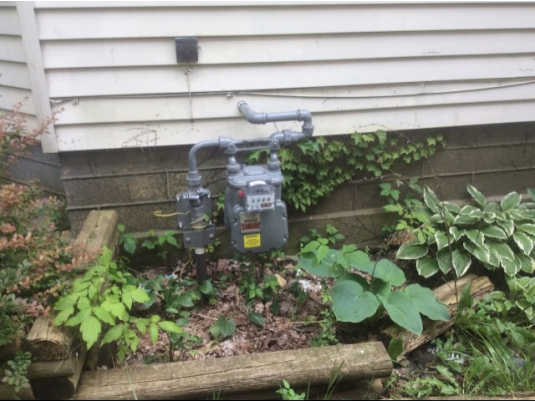
Exterior/Yard

Mercury-containing gas pressure regulators

Yes

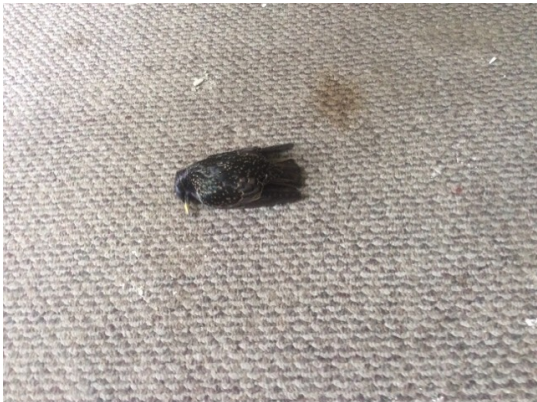
Fire extinguishers	No
Compressed gas cylinders	No
Electronics	No
Chemicals	No
Pesticides	No
Paints	No
Solvents	No
Used oil	No
Fuels and fuel oil tanks	No
Biological waste (vermin, pigeon excrement) Room Attach Image	Yes Bedroom

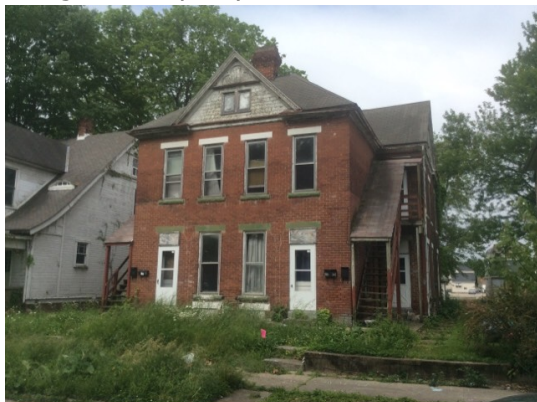
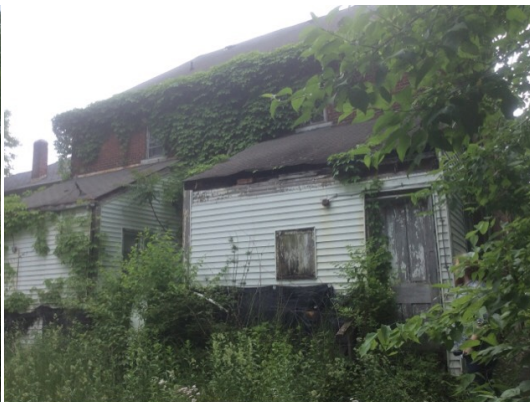
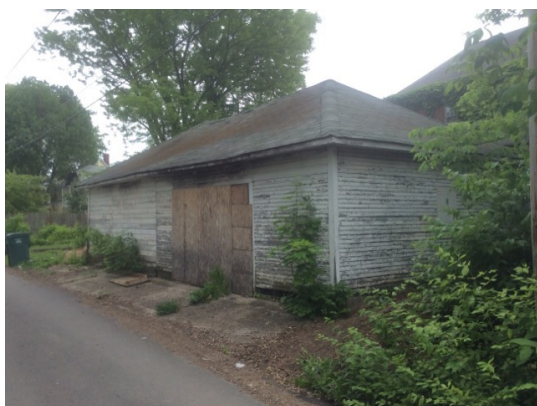
Date of Survey May 26, 2016
Name of Surveyor Greg Ubehlhor
Applicant Name City of Richmond
Property Address 208 South 10th Street Richmond IN
Image of Property

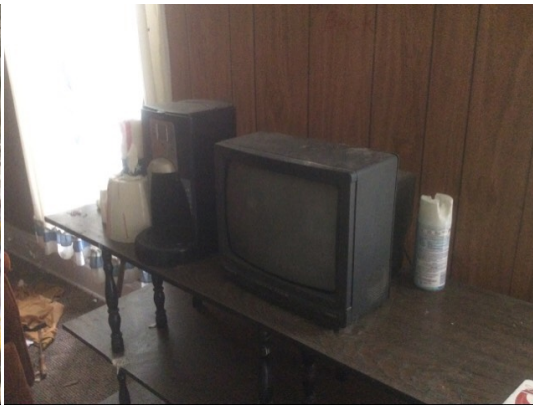
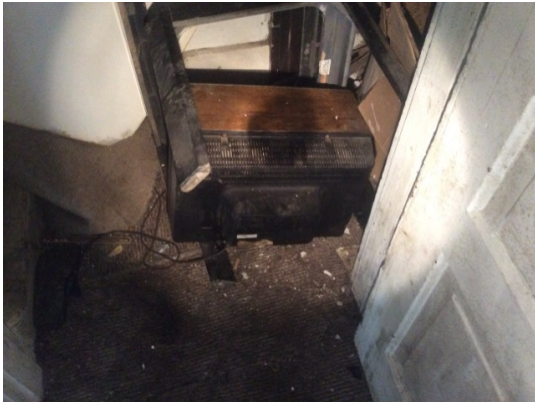
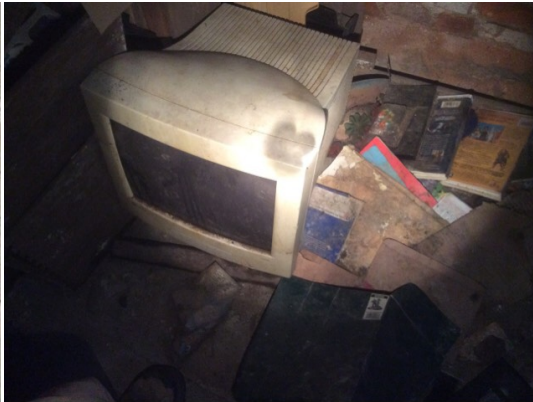
Fire extinguishers	No
Compressed gas cylinders	No
Electronics	Yes
Room	Multiple Rooms
Attach Image

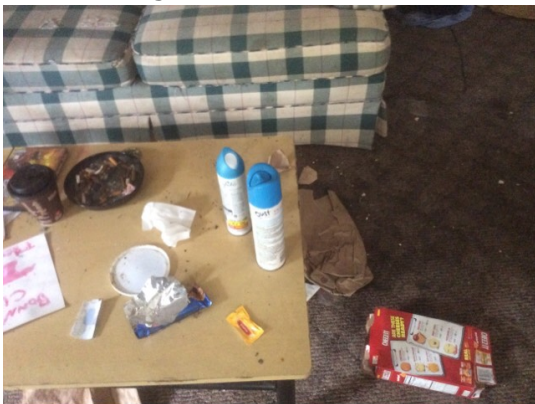
Chemicals
Room
Attach Image

Yes
Multiple Rooms

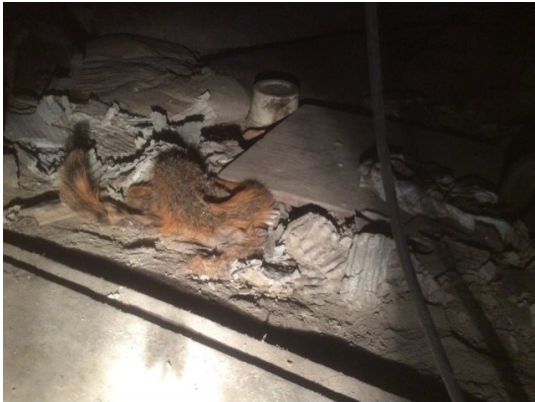
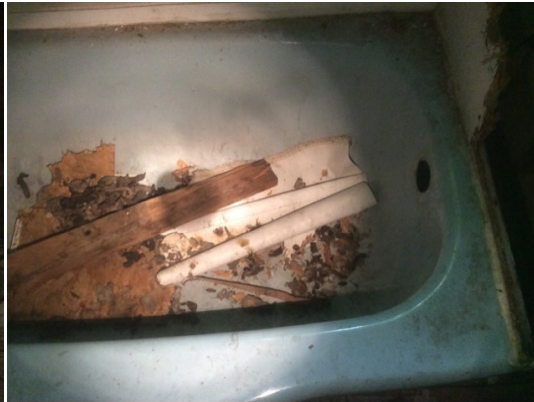
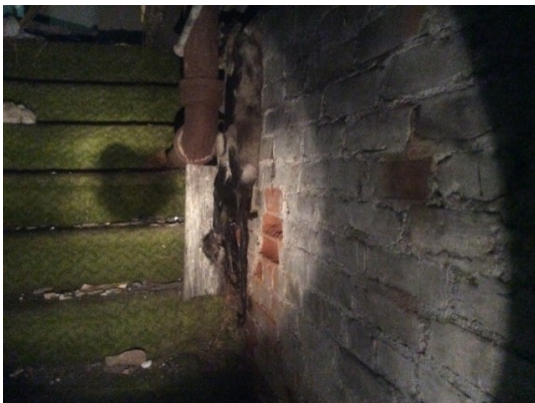
Solvents	No
Used oil	No
Fuels and fuel oil tanks	No
Biological waste (vermin, pigeon excrement)	Yes
Room	Multiple Rooms
Attach Image

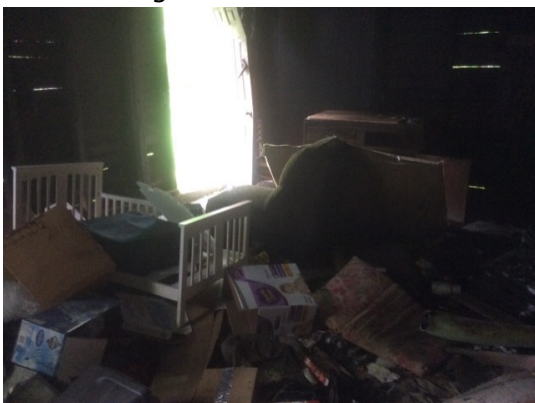
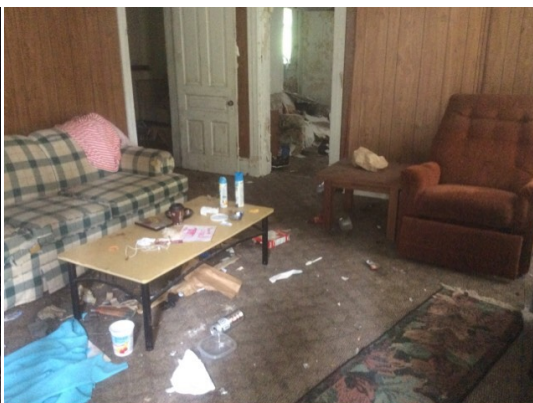
Furniture
Room
Attach Image

Yes
Garage

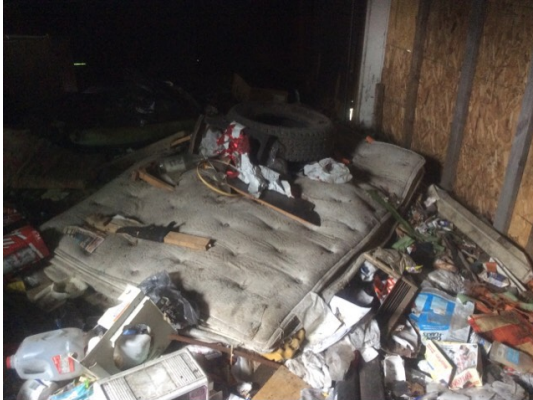
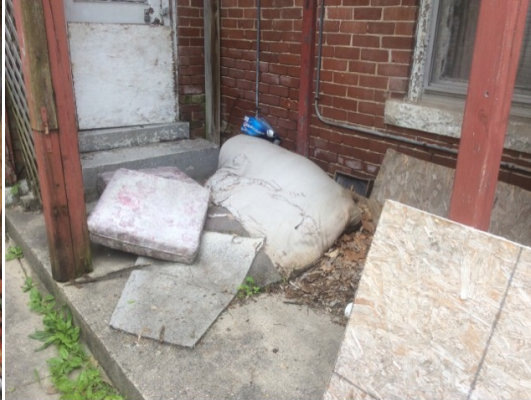
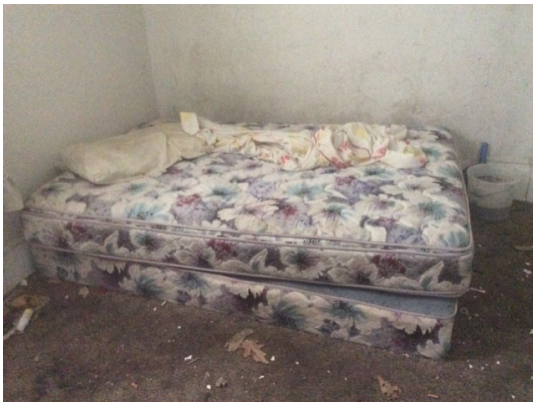
Mattresses

Yes

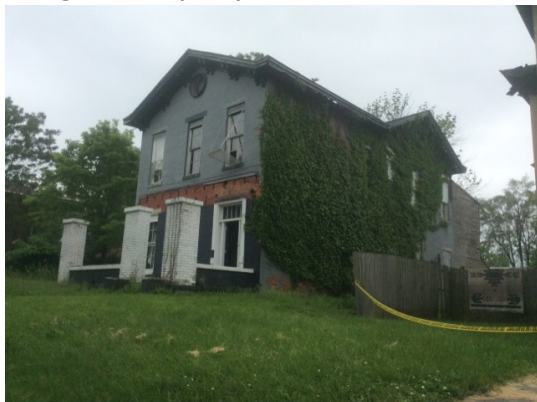
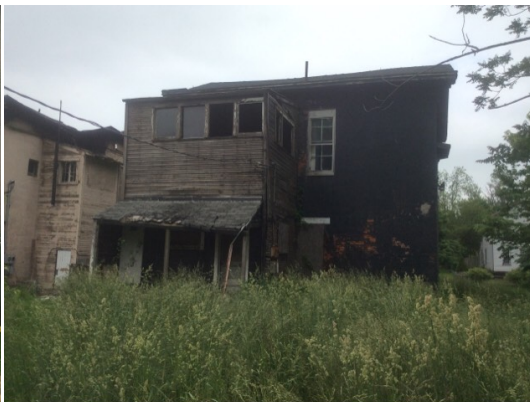
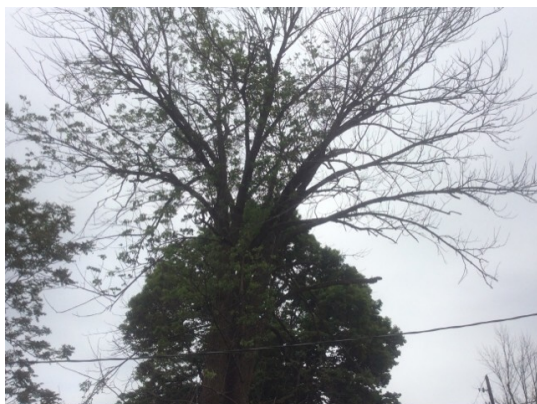
Date of Survey May 26, 2016
Name of Surveyor Greg Ubehlor
Applicant Name City of Richmond
Property Address 322 North 12th Street Richmond IN
Image of Property

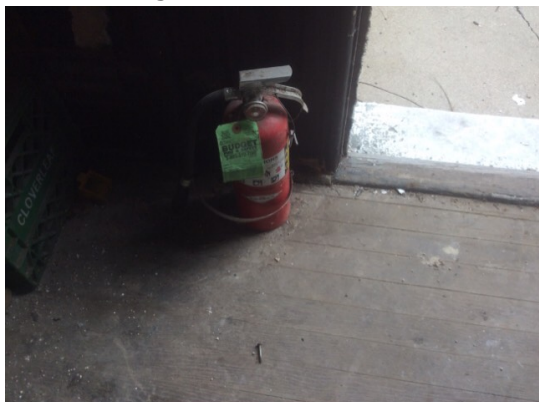
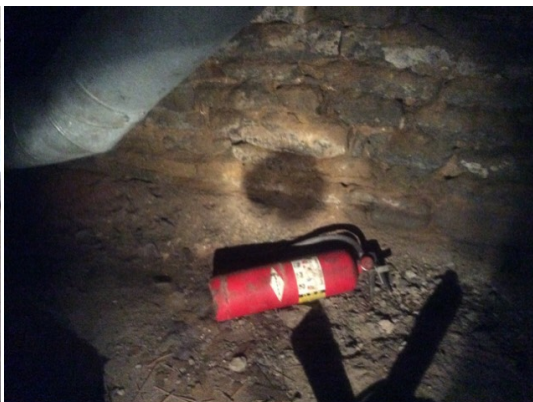
Fire extinguishers

Yes

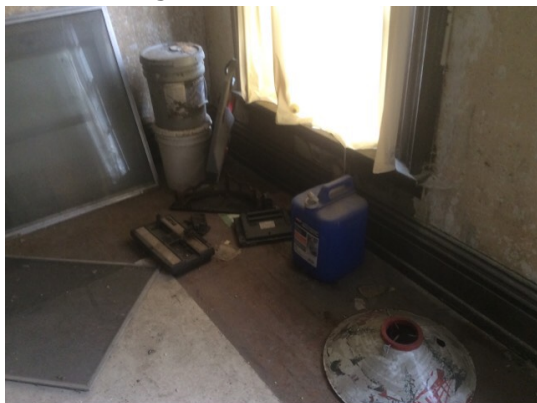
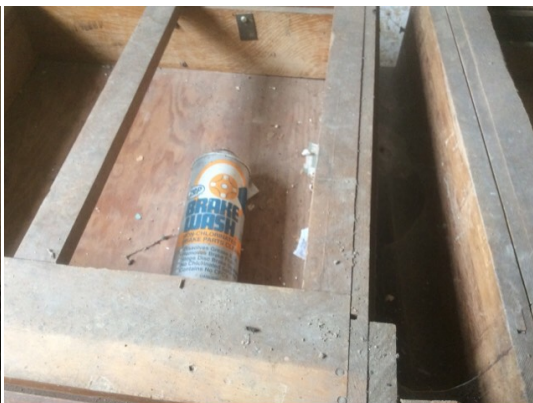
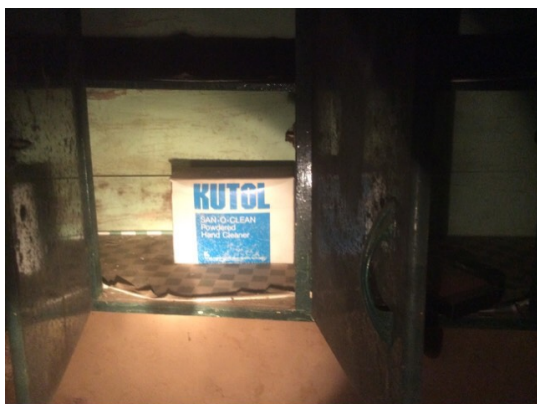
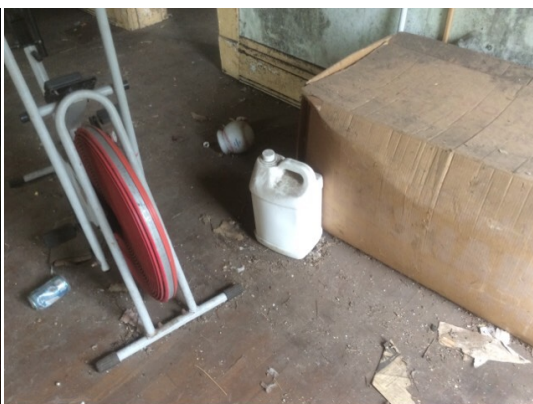
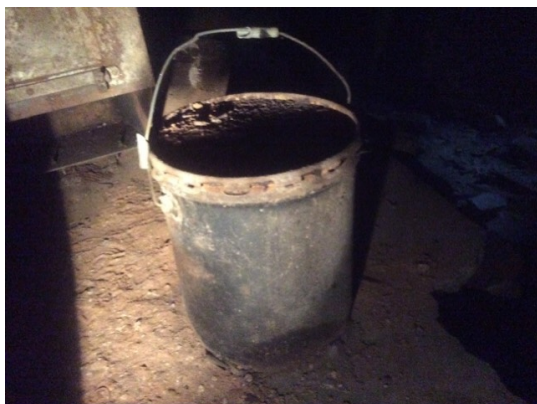
Chemicals

Yes

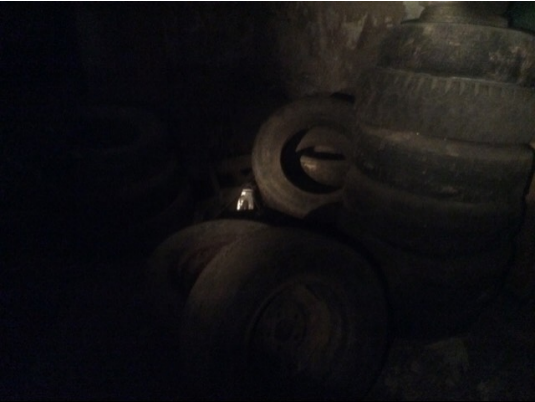
Scrap tires	Yes
Room	Kitchen

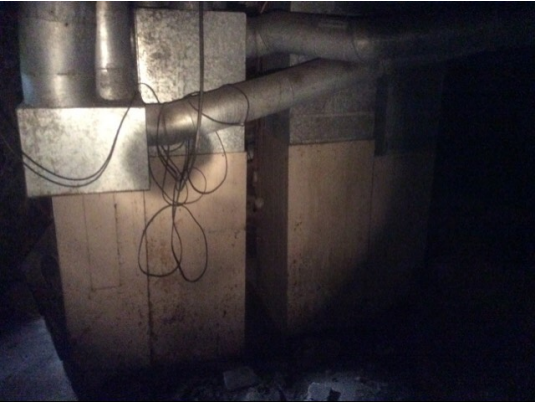
Major appliances	Yes
Room	Basement

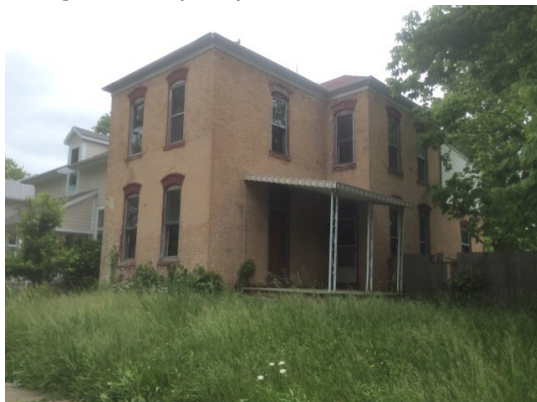
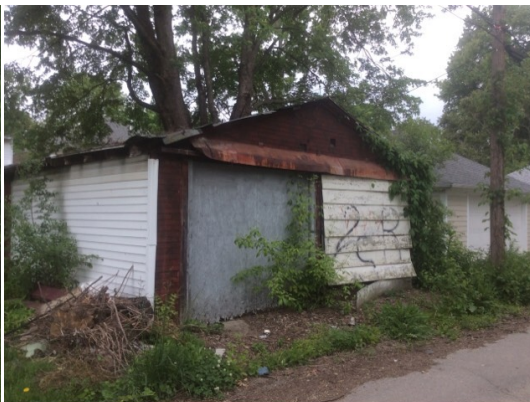
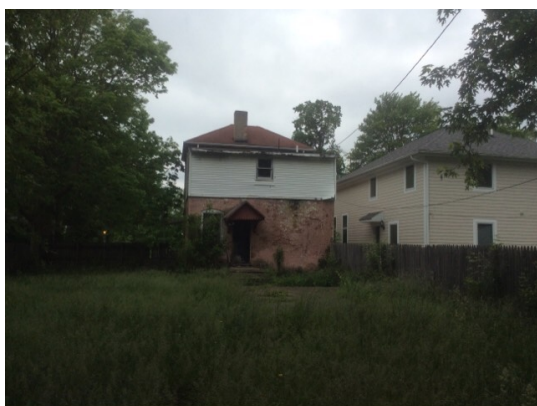
Date of Survey May 26, 2016
Name of Surveyor Greg Ubehlhor
Applicant Name City of Richmond
Property Address 341 South 10th Street Richmond IN
Image of Property

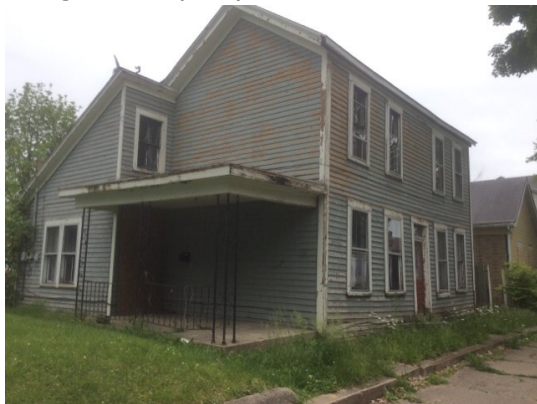
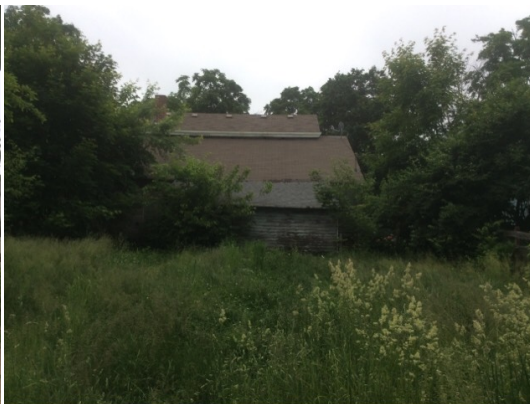
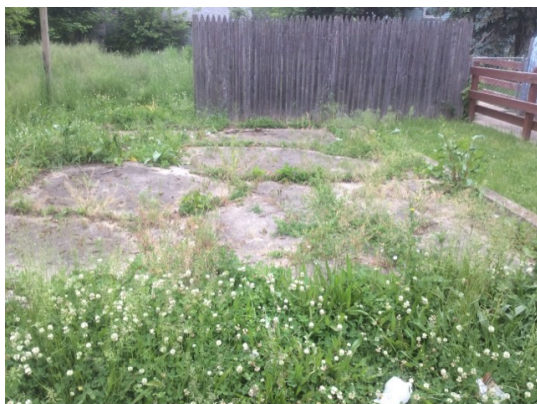
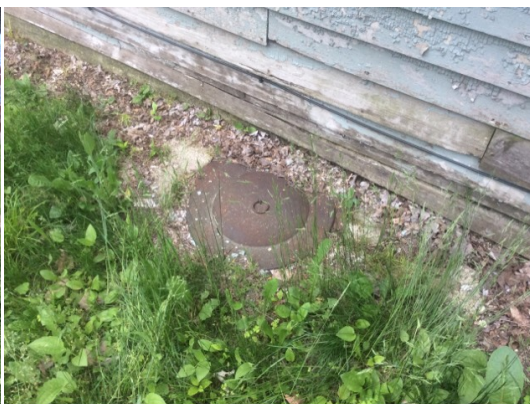
Date of Survey May 26, 2016
Name of Surveyor Greg Ubehlhor
Applicant Name City of Richmond
Property Address 439 South 7th Street Richmond IN
Image of Property

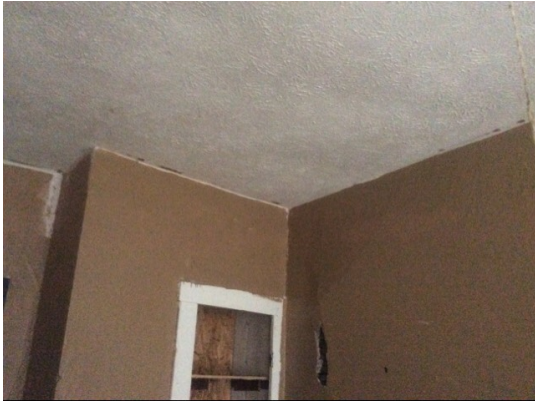
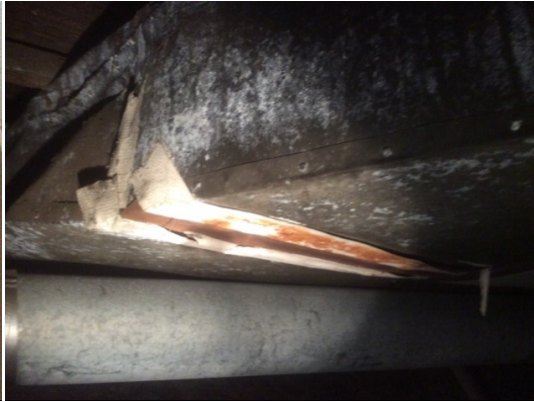
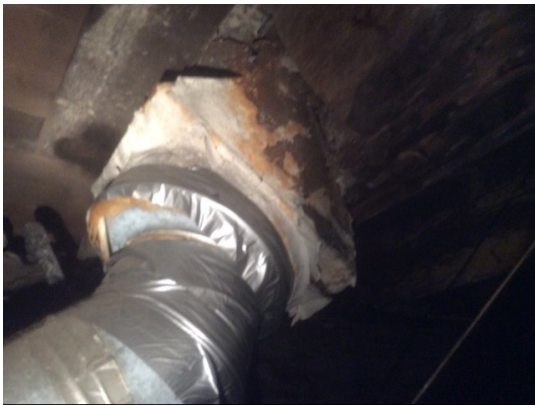
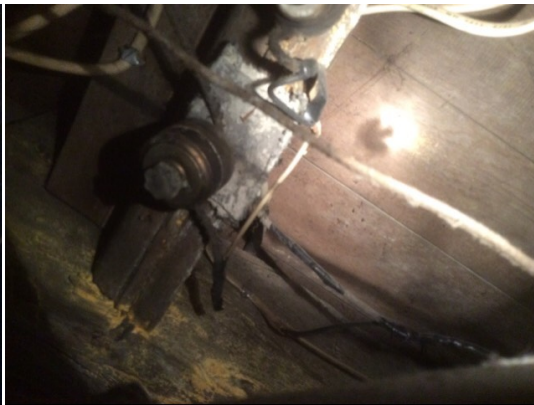
POTENTIAL ASBESTOS-CONTAINING MATERIALS (ACM) Yes
Room Multiple Rooms

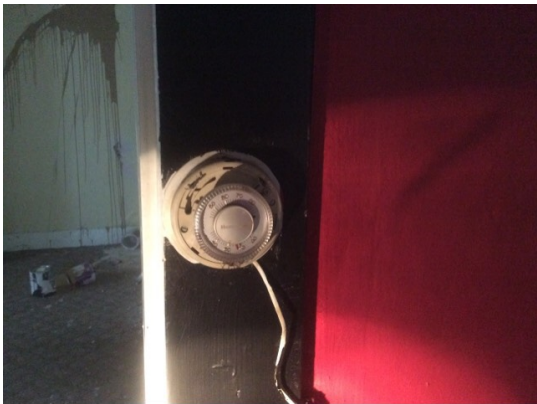
Living Room

Yes

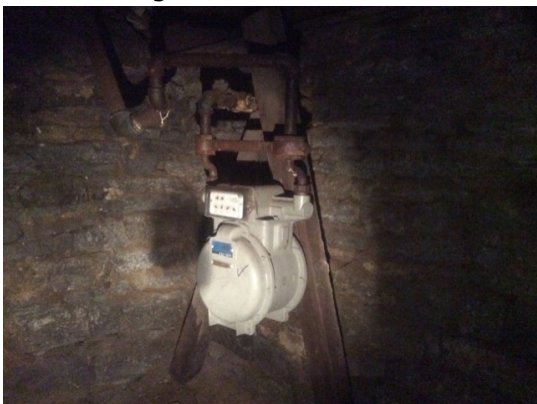
Basement

Yes

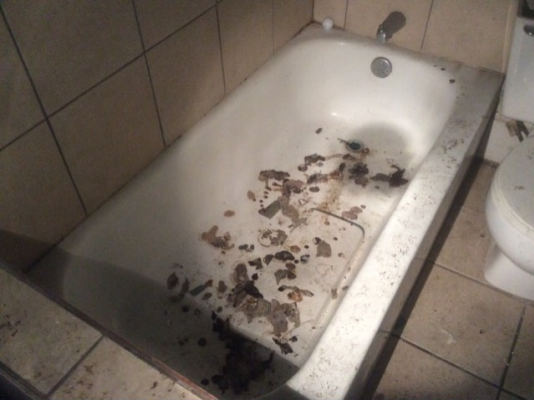
Solvents	No
Used oil	No
Fuels and fuel oil tanks	No
Biological waste (vermin, pigeon excrement)	Yes
Room	Multiple Rooms

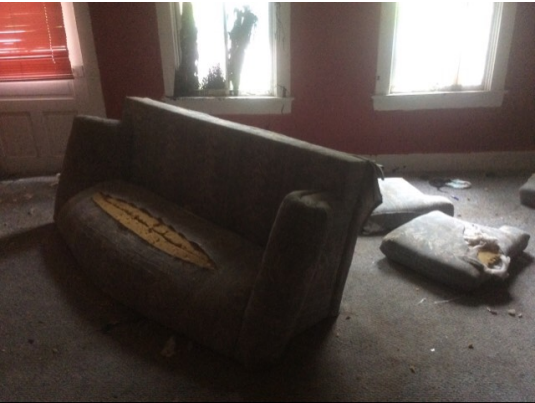
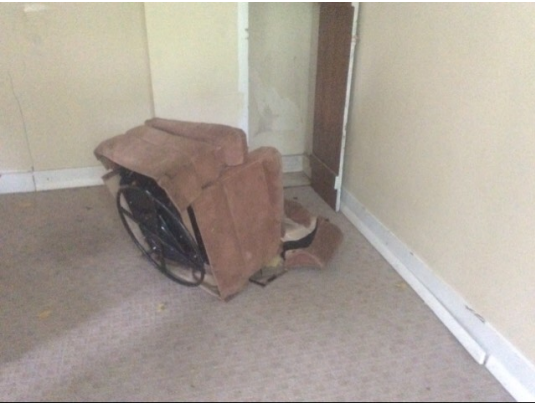
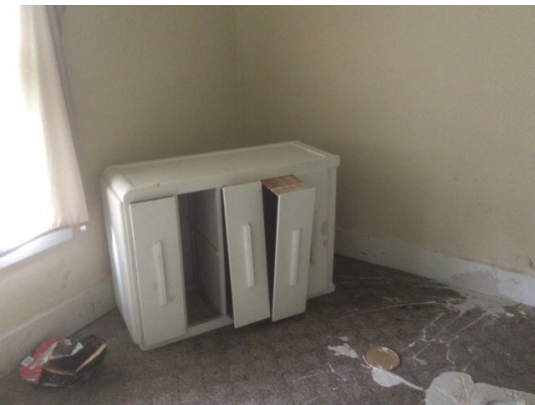
Room	Multiple Rooms
------	----------------

Furniture	Yes
-----------	-----

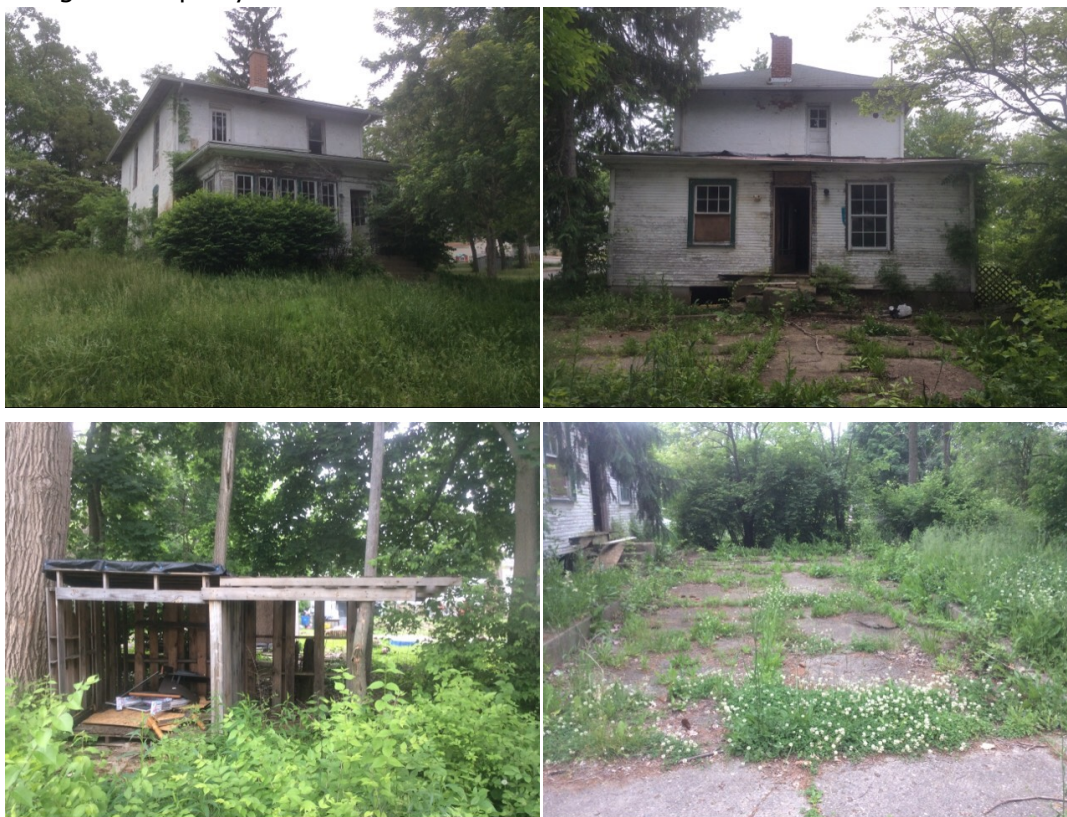
Date of Survey May 26, 2016
Name of Surveyor Greg Ubelhor
Applicant Name City of Richmond
Property Address 835 South 12th Street Richmond IN
Image of Property

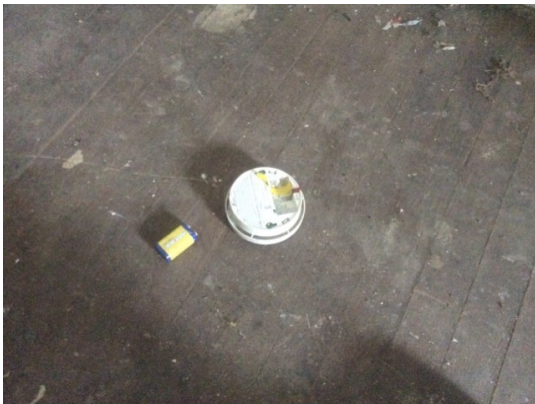
Upper hall

Yes

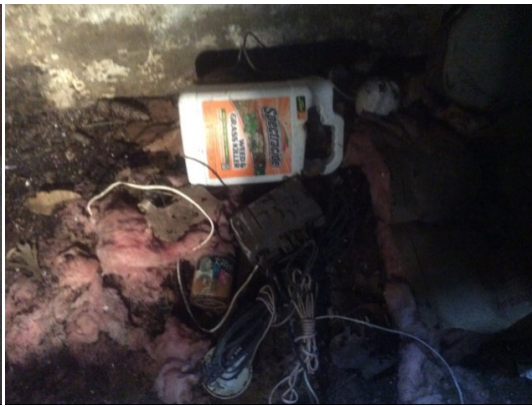
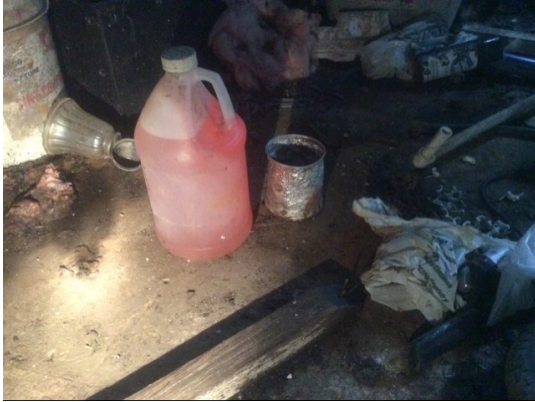
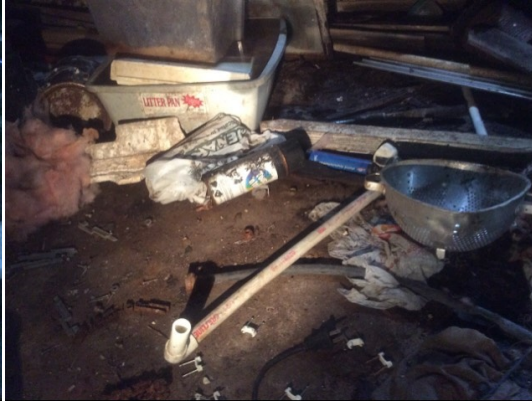
Fire extinguishers	No
Compressed gas cylinders	No
Electronics	No
Chemicals	Yes
Room	Multiple Rooms
Attach Image

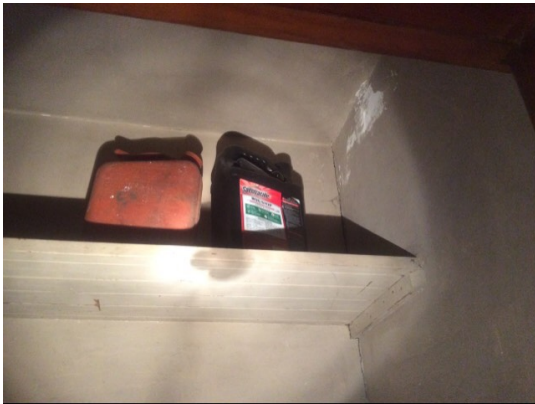
Closet

Pesticides

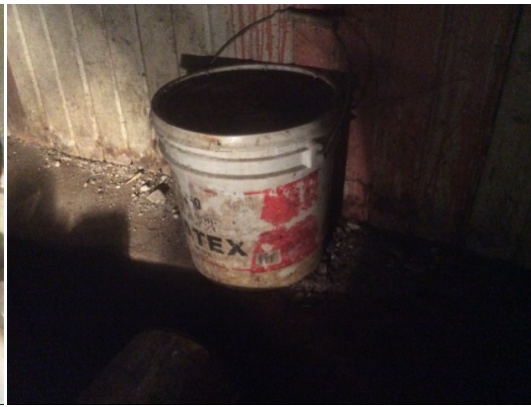
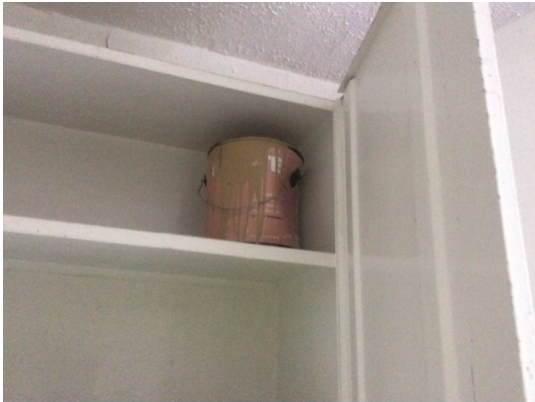
Multiple Rooms

Paints

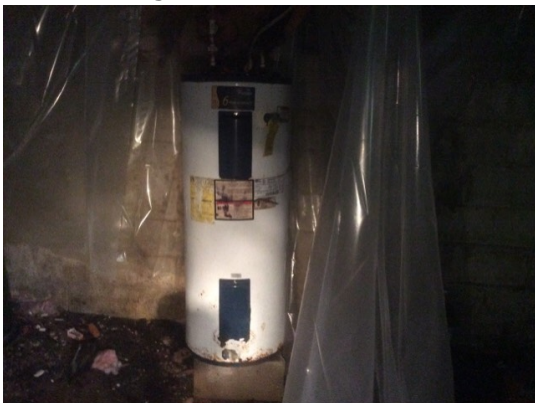
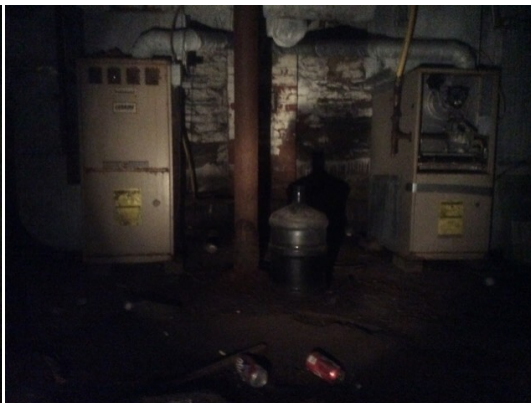
Basement

Major appliances
